Tooting Common

Heritage Tree Survey

The Landscape Group, University of East Anglia

May 2015

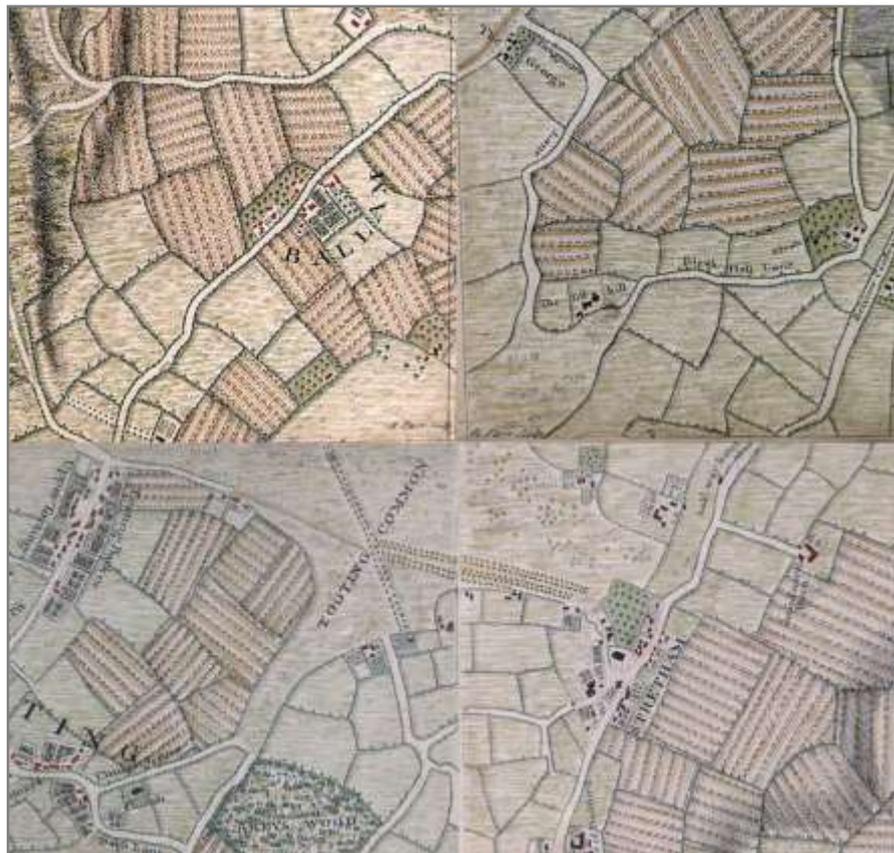
Figure 2.1 – Rocque's map of London and the country ten miles round.

- 2.3.2. Two maps by John Rocque, published in 1746 and 1768, give some indication of the appearance of Tooting Common and its surroundings in the eighteenth century. The Common is depicted in similar fashion on both maps, with the roads crossing from east to west between Upper Tooting and Streatham and from north to south between Balham and Streatham. The avenue of trees that later became known as Dr Johnson Avenue is clearly shown, and crosses Tooting Bec Road to continue along the line of what is now West Drive. The southern end of the avenue terminates close to a house on the edge of the common. It is depicted as a single avenue of what were presumably well-established trees. Further avenues of trees are shown running between Dr Johnson Avenue and Streatham, alongside Tooting Bec road. Four lines of trees are shown, creating two separate avenues on either side of the road. For a short section an additional line of single trees is shown running parallel to the southern avenue.

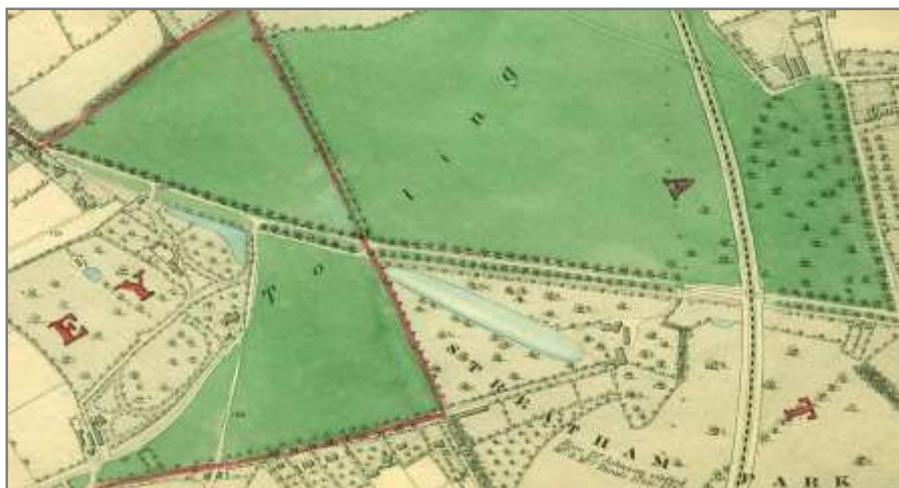
Figure 2.2 – Detail from Stanford's 1862 map of London showing the southern end of Tooting Common.

- 2.4.3. Dr Johnson Avenue and the avenue along Tooting Bec Road are both shown, although the use of different tree symbols suggest the latter was a more substantial feature. A continuous line of trees is shown along the western edge of Garrad's Road, which at its northern end is joined by a parallel line of trees on the Common, forming a short section of avenue.

- 2.4.4. Stanford's map makes clear the relationship between the common and mansions and villas which surrounded it, with the Common forming the backdrop to areas of garden and parkland. There is little evidence of concerted efforts to screen out the common; indeed the densest perimeter planting around Streatham Park is found on the opposite side to the Common.

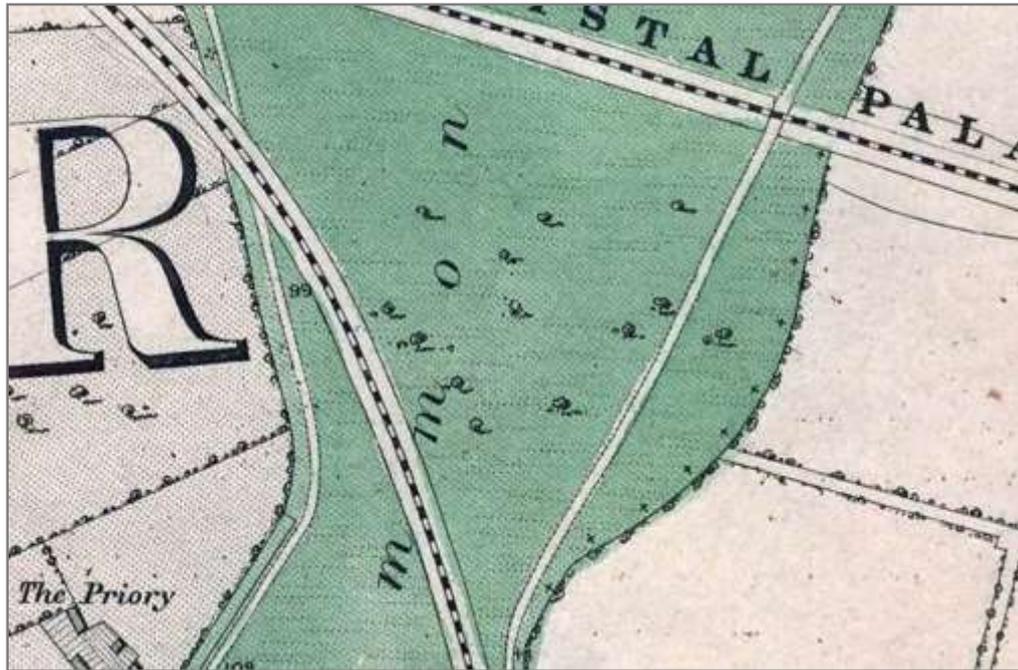
Figure 2.3 – Detail from Stanford’s 1862 map showing individual trees at the northern end of Tooting Common, probably survivors from the earlier landscape of common wood pasture.

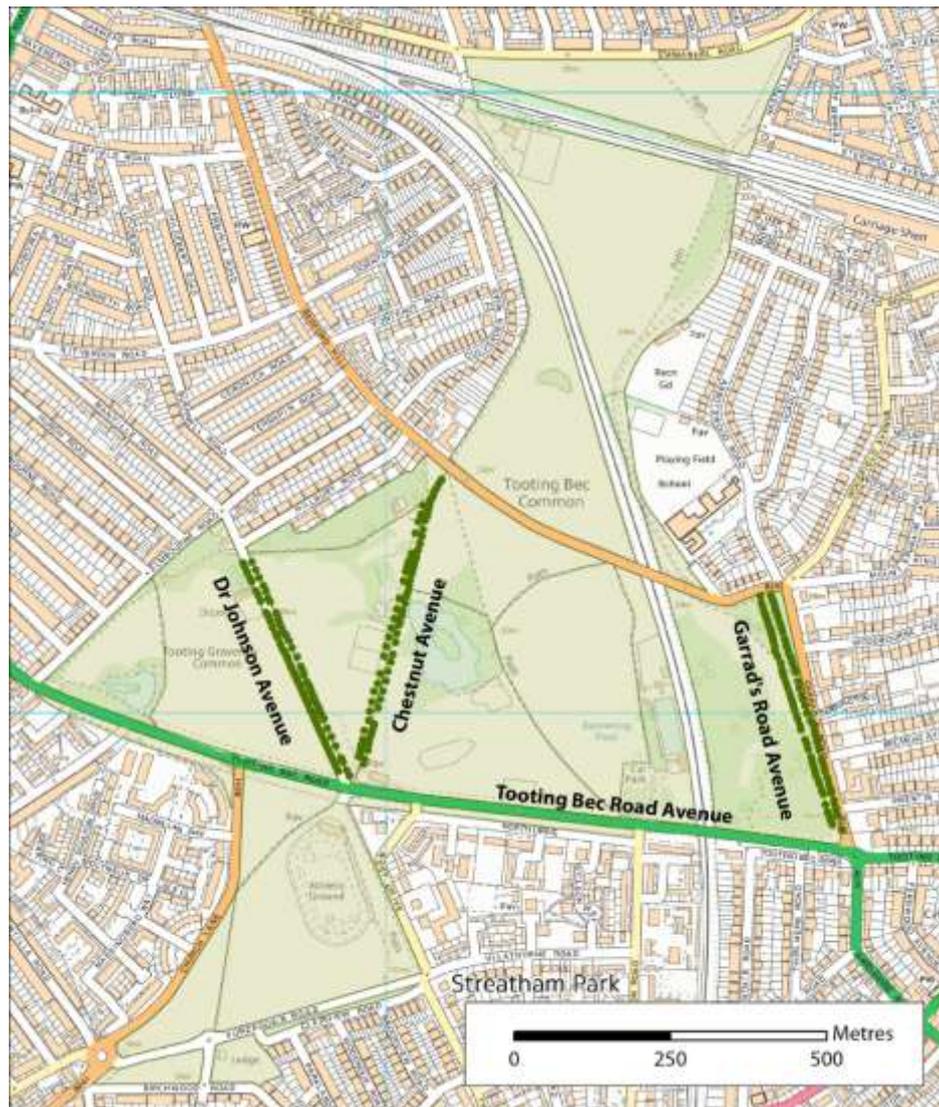
Figure 3.1 – Map of Tooting Common showing location of main avenues. Trees marked are those which are present today (Contains Ordnance Survey data © Crown copyright and database right 2015).

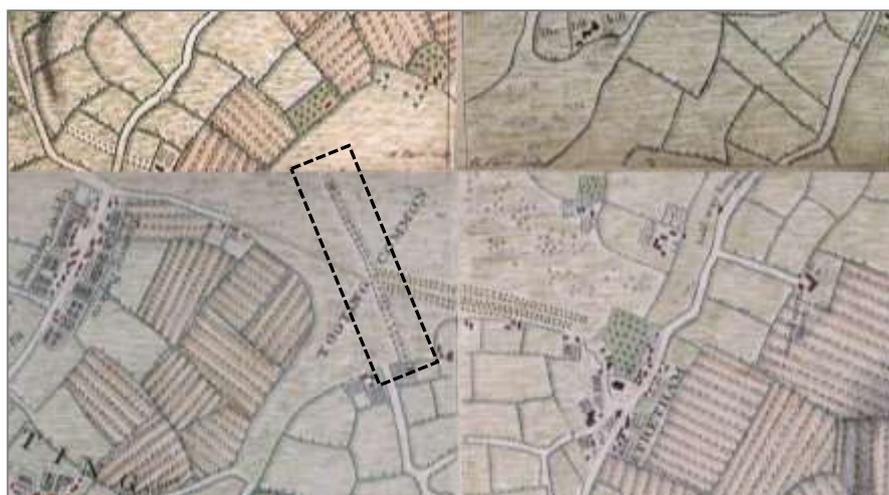
Figure 3.2 – Rocque’s map of London and the Country Ten Miles Round (1746) showing Dr Johnson Avenue extending both sides of Tooting Bec Road.

3.3.1. Today Dr Johnson Avenue runs between Hillbury Road and Tooting Bec Road. However, eighteenth-century maps such as Rocque’s maps of London and Surrey (Rocque 1746 and 1768) clearly show the avenue stretching beyond Tooting Bec Road, terminating near what is now Ullathorne Road. The avenue followed the boundary between the commons of Tooting Graveney to the west and Tooting Bec to the east, partly running along the line of the York Ditch. Faden’s map of the 25 miles around London shows the avenue extending beyond Tooting Bec Road with a portion of common extending to the east of this. That piece of common later became part of Streatham Park (Sexby 1905, 212) and later nineteenth-century maps appear to show part of the avenue still present along the western boundary of the park. By the 1890s the park had been replaced by housing, with the new road of West Drive marking the line of the former avenue.

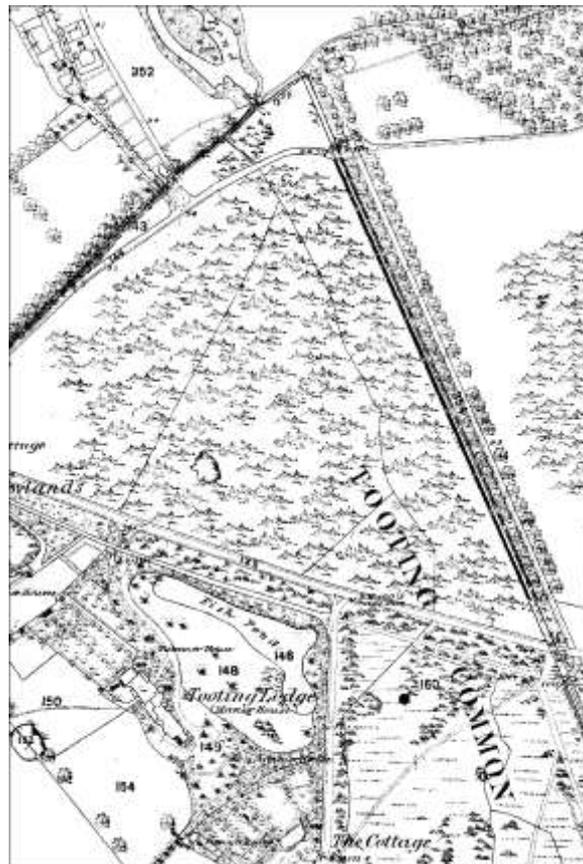
Figure 3.3 – Dr Johnson Avenue as depicted on the first edition Ordnance Survey 25 inch to 1 mile map (1868-75).

- 3.3.4. The large scale Ordnance Survey maps of the late nineteenth century and early twentieth century provide an opportunity to examine changes in the form of the avenue in more detail. The 25 inch to 1 mile map of the late 1860s shows the avenue as largely continuous with some small gaps shown halfway along each side. This map was revised in 1895-6, with this edition showing a large gap on the west side which appears to have been filled with younger specimens.

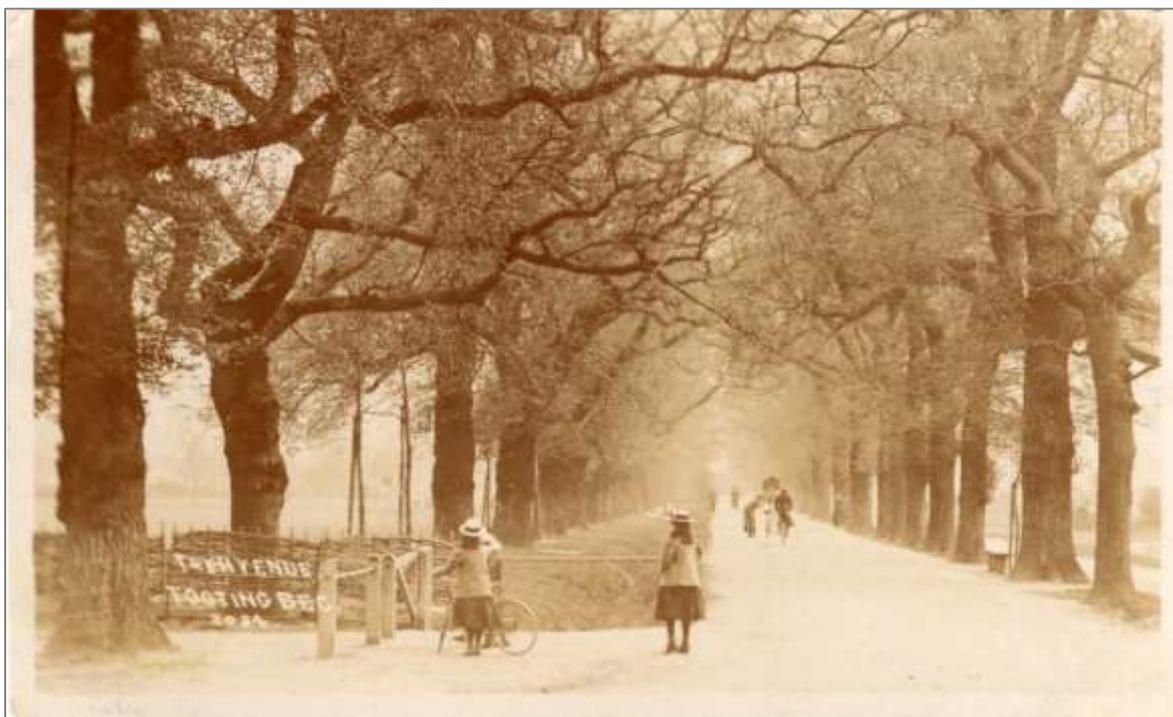
Figure 3.6 Dr Johnson Avenue in 1908, showing oaks of various sizes and ages, including some, to the left of the girl with the bicycle, which have clearly been recently planted (Patrick Loobey collection).

- 3.3.5. This mixture of planting is shown in more detail in a postcard dated 1908 (Figure 3.6) At this date the avenue is labelled simply as 'The Avenue'. The third edition of the 25-inch map, published in 1916, shows the avenue to have a very fragmented west side, but a much more uniform east side with regularly spaced trees and no significant gaps. The name in 1916 continued to be recorded as 'The Avenue'.

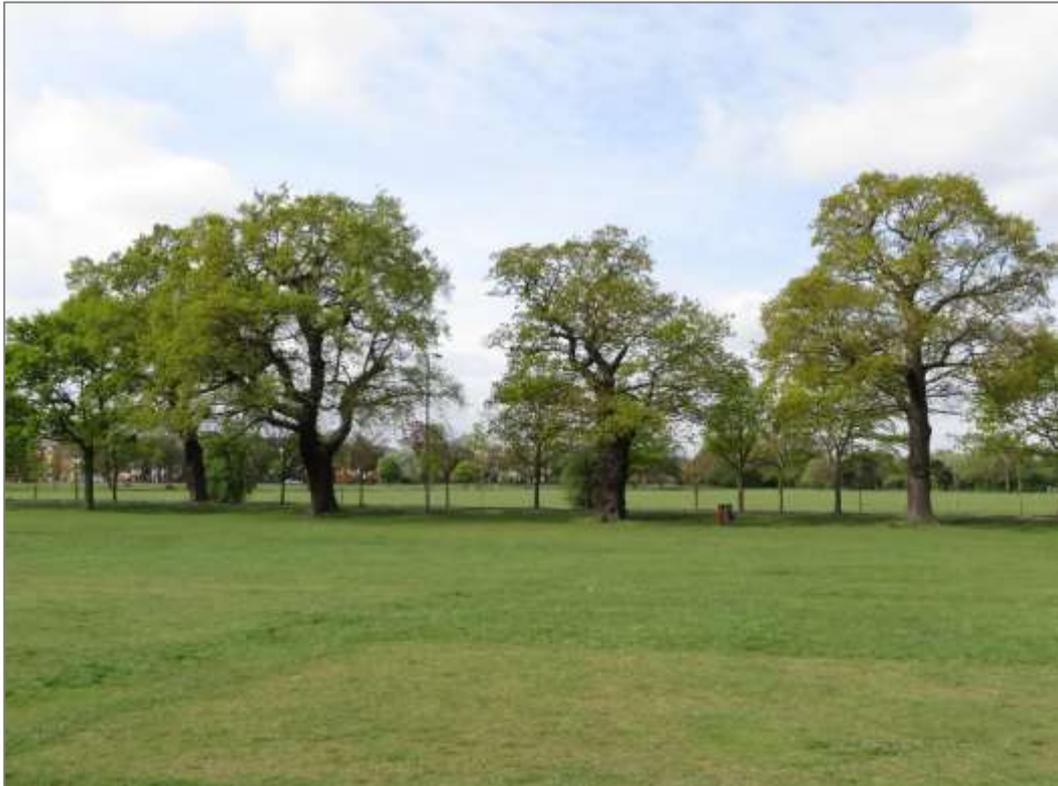
- 3.4.1. Dr Johnson Avenue currently comprises 46 trees on the west side and 37 on the east side (Treework Environmental Practice, 2015). The dominant species is English oak (*Quercus robur*) which accounts for 78 of the 83 trees (94%). The remaining 5 trees include 1 red oak (*Quercus rubra*) and 4 Cypress oaks (*Quercus robur* 'Fastigiata'). The trees have a very varied composition in terms of size and age, ranging from recently planted introductions with stem diameters of 6-20cm to large survivors from earlier phases of the avenue's history with diameters between 100-140cm and circumferences between 3 and 4m. Five trees fall into this latter category and clearly represent the oldest surviving trees within the avenue. Two of these lie on the west side of the avenue (T701 and T710) and three together in the middle of the east side (T873, T874, T875).

Figure 3.8 – Oak trees on the east side of Dr Johnson Avenue (T873-5).

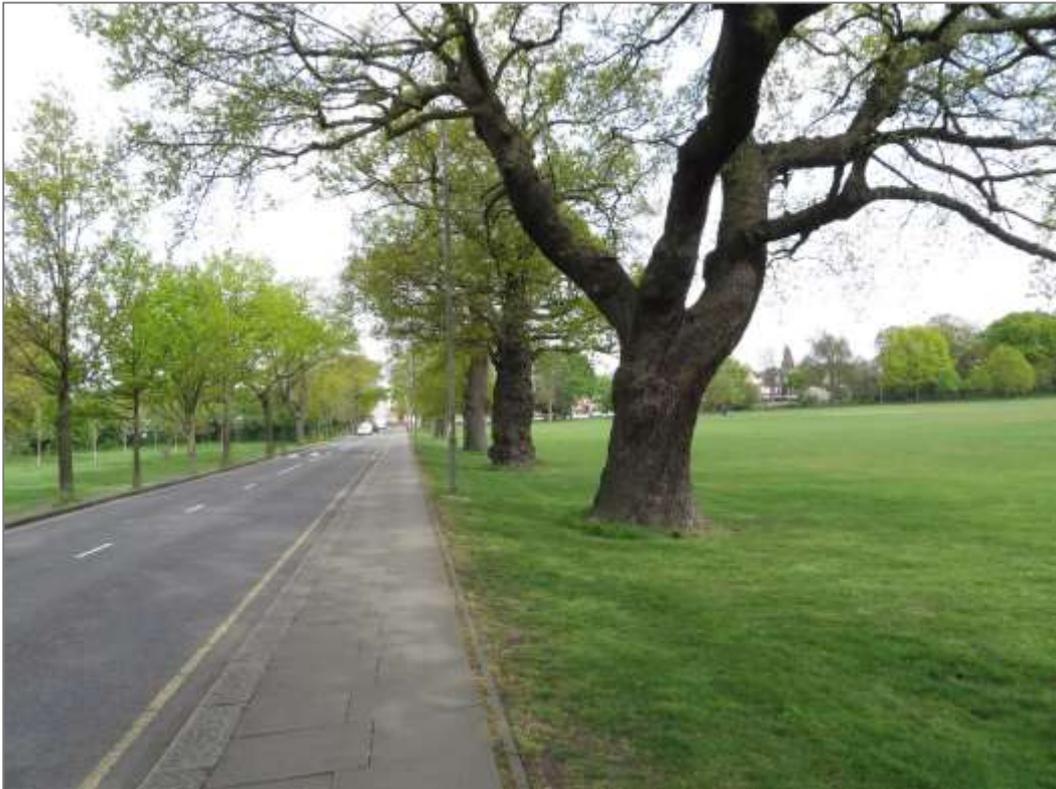
Figure 3.9 – Oak trees on the east side of Dr Johnson Avenue (looking north).

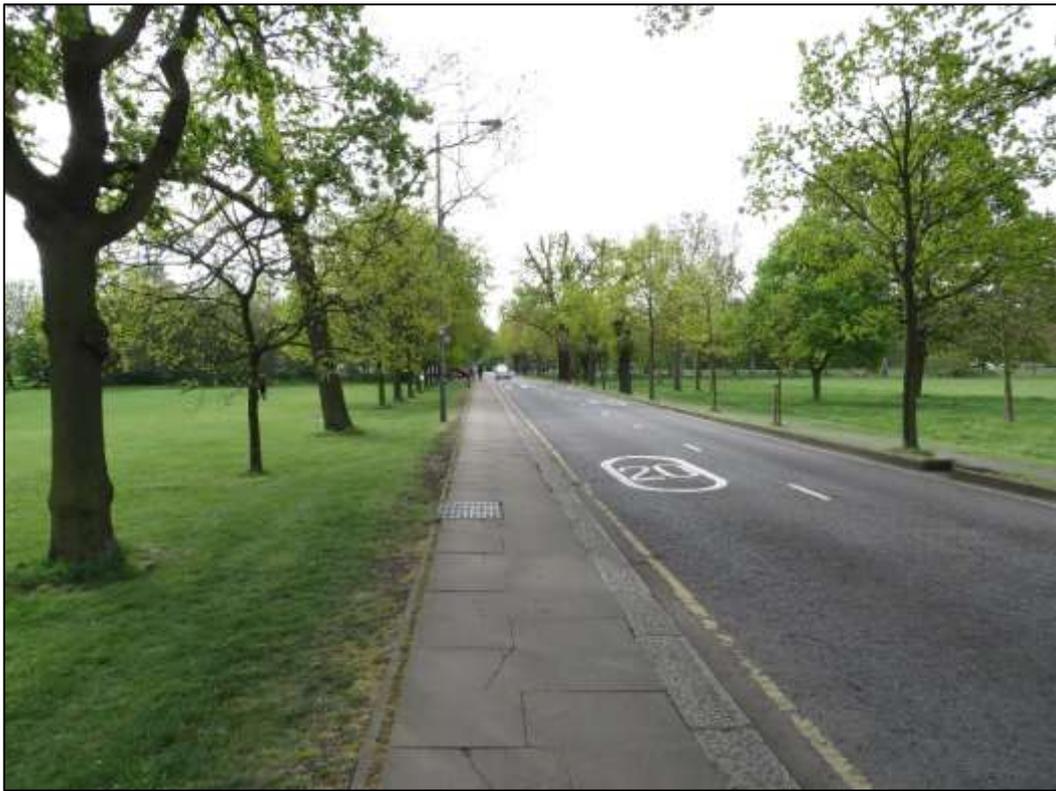
Figure 3.10 – Dr Johnson Avenue (looking south) showing oak trees of various sizes and ages.

- 3.4.3. Of the smaller trees in the avenue it can be said with more confidence that most are the result of various schemes of replanting carried out in the late nineteenth and twentieth centuries. The average stem diameter is 36cm (circumference 112cm) with a range of trees of various sizes and ages that, if properly maintained, will ensure the continuation of the avenue as an important part of the landscape of Tooting Common. Overall the trees here are characterised by younger specimens, with 56 trees having a circumference of less than 100cm.

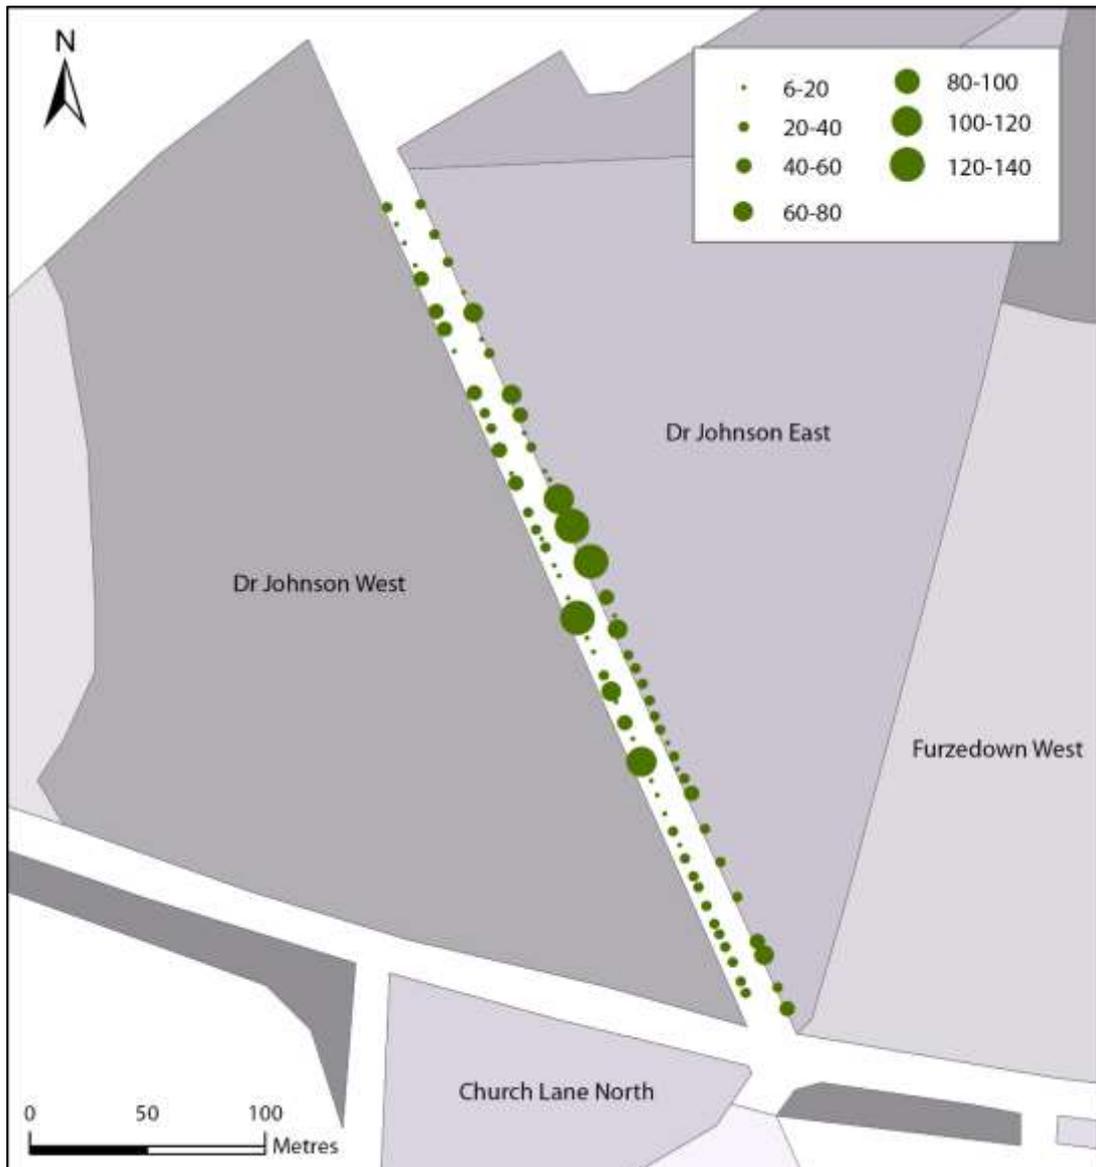
- 3.4.4. A tree condition survey carried out in March 2015 classed 49 of the trees as being in 'Good' condition and 34 as 'Fair'. None were recorded as poor, though three trees (T706, T708, T710) were thought to show signs of 'likely' or 'probable' Acute Oak Decline (Treework Environmental Practice 2015).

Figure 3.11 – Variations in stem diameter of trees in Dr Johnson Avenue (in cm).

Issues	Suggested Actions
Uneven spacing between trees	Replant gaps with English oak and monitor health of newly planted specimens. In the medium term some thinning of closely spaced younger specimens may be necessary.
Tree damage caused by traffic	Investigate feasibility of closing road to traffic.
Potential long term problems associated with Acute Oak Decline	Continue to monitor trees for signs of AOD In the long term consideration might be given to planting an outer avenue with a related species more resistant to climate change (Hungarian oak – <i>Quercus frainetto</i> or Downy oak – <i>Q. pubescens</i>).
Historical context of Avenue	Continue to research history of Avenue to shed light on its origins and development.
Problems relating to specific trees	Follow guidance in 2015 Tree Condition Survey.

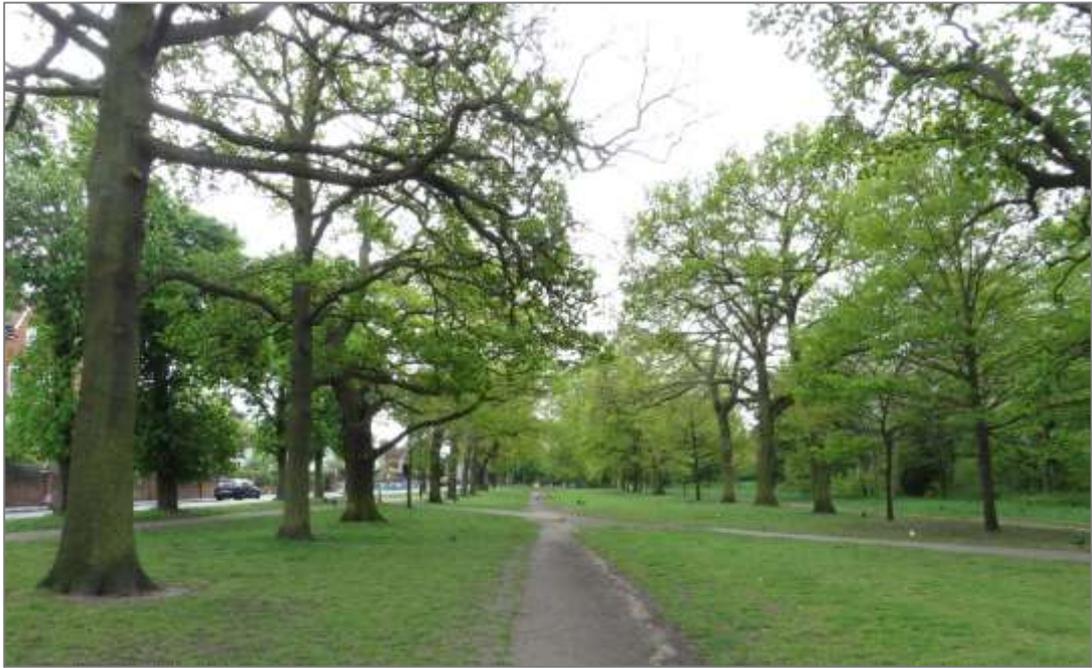
Figure 3.12 – Garrad's Road Avenue looking south.

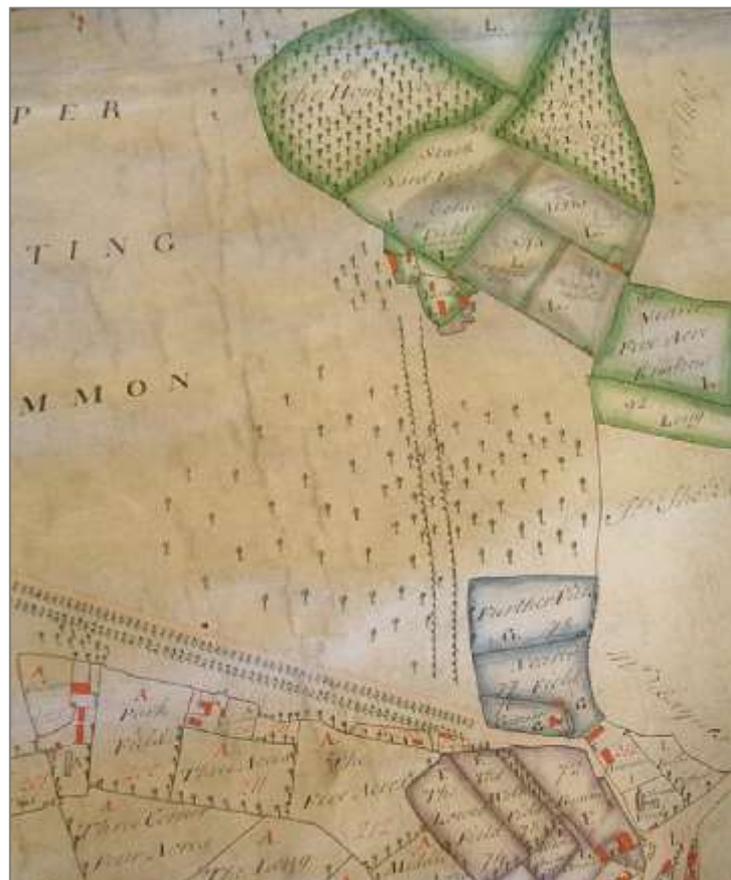
Figure 3.13 – Garrad's Road Avenue as shown on a map of 1729 (London Metropolitan Archives E/BER/S/E5/3/1).

- 3.5.2. The map of 1729 appears to show Garrad's Road Avenue running between a group of properties on the edge of the Common towards the end of Tooting Bec Road Avenue. At this date the Common extended further to the east than it does today. Its depiction raises a number of interesting issues. The fact that numerous existing Common trees are shown *inside* the avenue suggest that it had only been recently planted and that these trees were yet to be cleared. This is reinforced by the fact that the surveyor uses a different, smaller tree symbol for those trees in the avenue, implying they were young trees. An alternative, though probably less likely, explanation may be that at the time the map was drawn the avenue had not been planted; what is shown is a proposed, rather than existing avenue. Either explanation may account for its absence from Rocque's map of 1746 – either because it was still a young and poorly established feature, or because it was yet to be planted.

- 3.9.1. The longest and most elaborate avenue depicted on eighteenth-century maps was that which ran from east to west across the southern edge of Tooting Common. The map of 1729 (Figure 3.13) and Rocque's maps of London and Surrey (Rocque 1746 and 1748) show this as a double avenue, with two rows of trees to the north of the road and two below. The avenue is shown starting alongside Dr Johnson Avenue in the west and running eastwards towards Streatham, stopping at the edge of the Common. Later references to the avenue reveal that elm was the predominant species, which eventually led to its demise as a result of Dutch elm disease in the twentieth century (Tooting Common Management Plan 1988, 28). Young elm suckers can still be found along the north side of Tooting Bec Road.

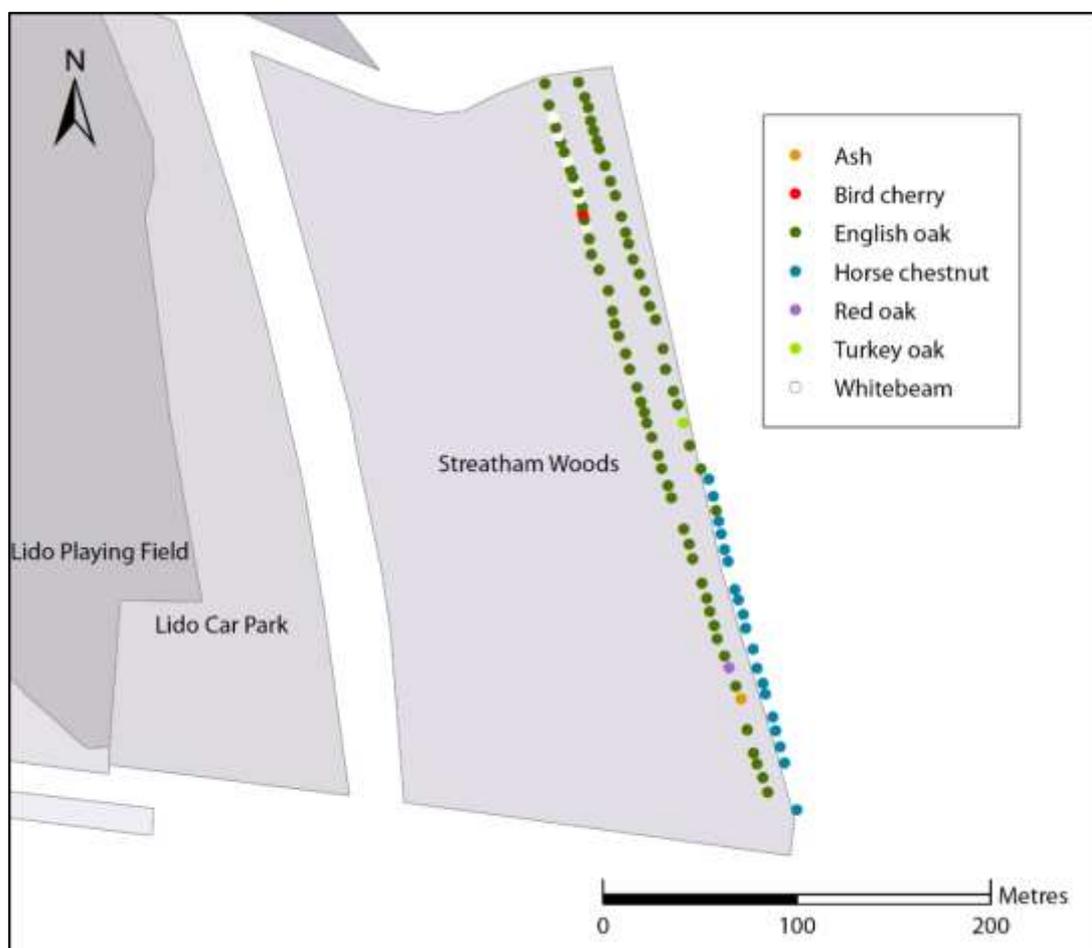
3.6.1. Garrad’s Road Avenue currently contains 97 trees of 7 species (Treework Environmental Practice 2015). English oak is the dominant species, accounting for 70% of the total trees. The second most common species is horse chestnut (*Aesculus hippocastanum*), which is confined to the southern end of the western side of the avenue and makes up 20% of the total. Of the remaining trees, there are 6 whitebeam (*Sorbus aria*), which seem to have been chosen for replanting part of the northern end of the avenue in the twentieth century, given their size and limited distribution. In addition there are single specimens of ash (*Fraxinus excelsior*), bird cherry (*Prunus padus*), red oak and turkey oak (*Quercus cerris*).

Figure 3.17 – Trees in Garrad’s Road Avenue by species.

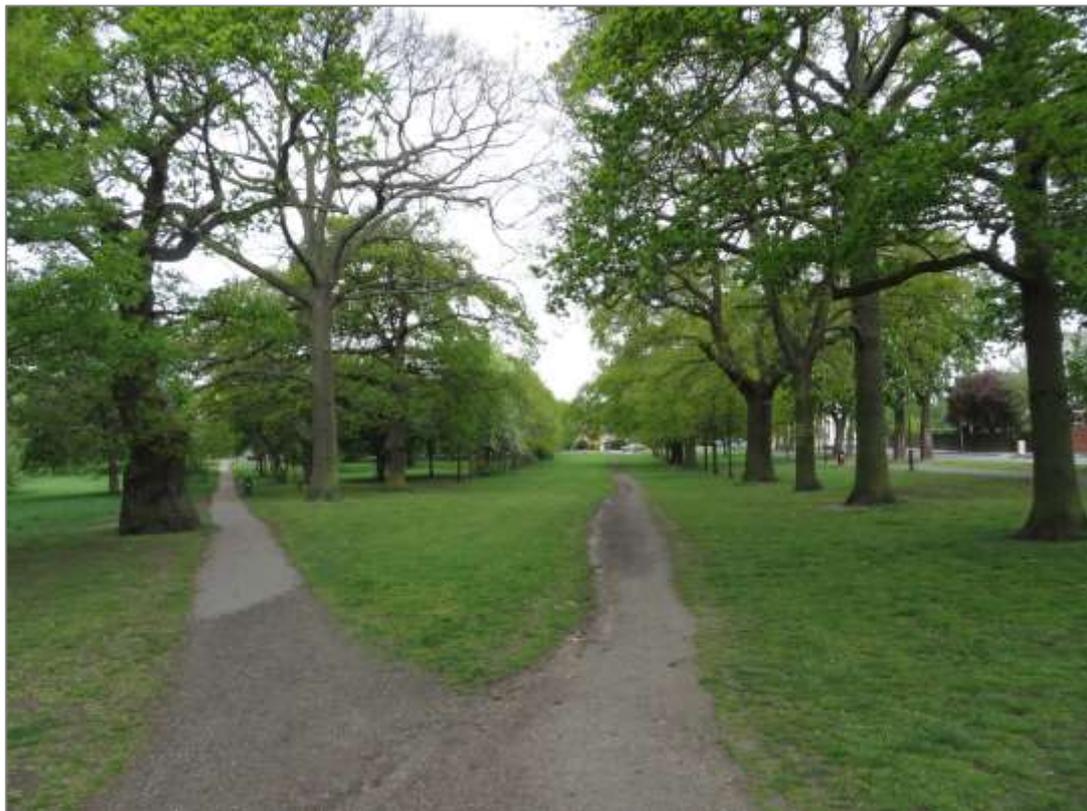
Figure 3.18 – Garrad's Road Avenue looking north towards Bedford Hill, showing some of the larger English oak trees which represent the oldest trees in the avenue.

- 3.6.4. A similar date of planting to Dr Johnson Avenue could be inferred from the current species composition of Garrad's Road Avenue, where English oak is predominant, though not to quite the same extent as in Dr Johnson Avenue. Oak does, however, particularly dominate the northern end of the avenue which, to judge from the cartographic evidence, represents the older and more complete end of the avenue. The larger size of the trees in Garrad's Road Avenue, compared to Dr Johnson Avenue, may be due to the more favourable conditions here – trees growing on water retentive clay soils rather than the sands and gravels of western part of the common. On the basis of surviving trees and cartographic evidence an early eighteenth-century date seems plausible for both avenues.

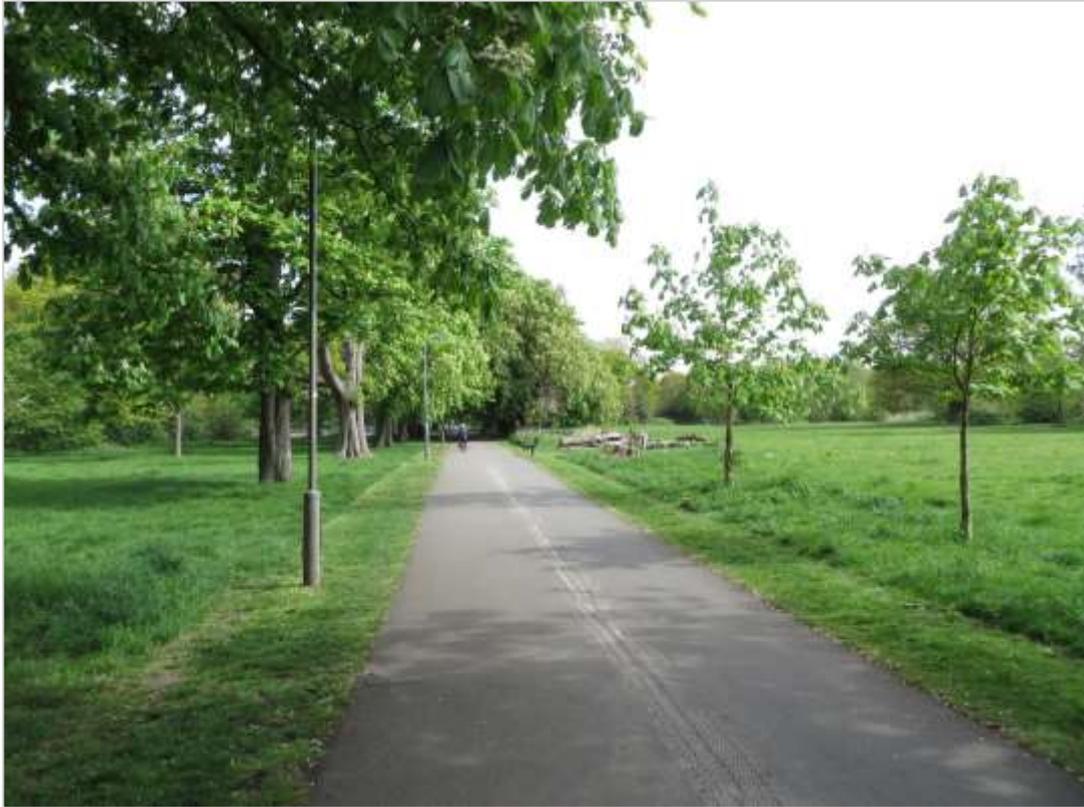
Figure 3.20 – Chestnut Avenue looking north.

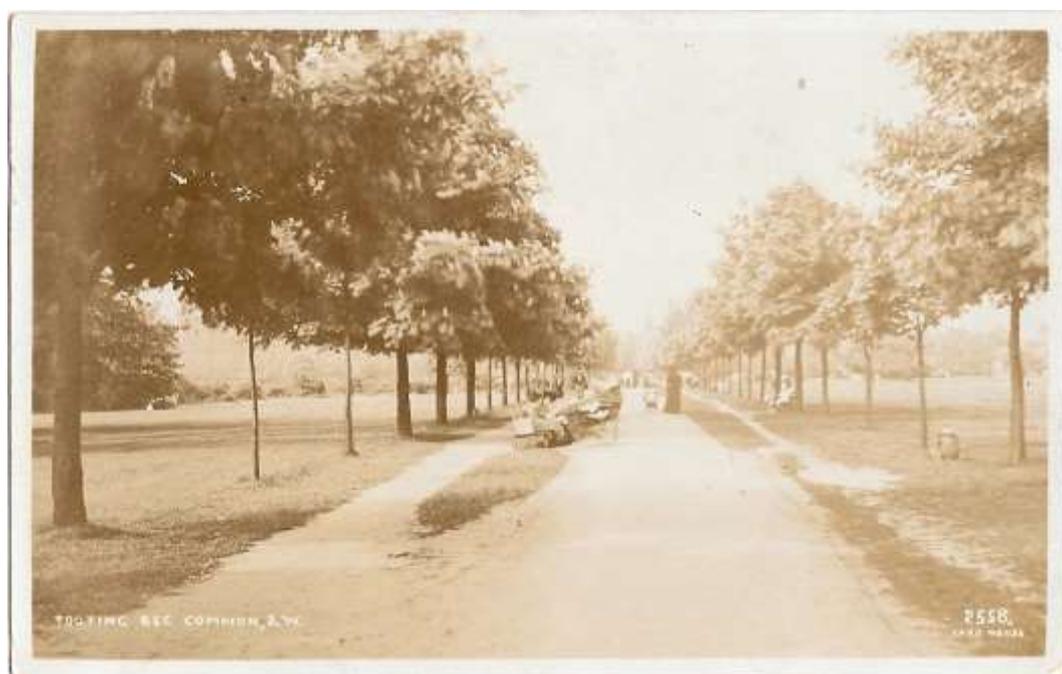
Figure 3.21 – Chestnut Avenue looking from north to south, towards Tooting Bec Road (Patrick Loobey Collection).

- 3.8.2. Thirteen trees have stem diameters greater than 80cm and circumferences of 250cm and more. These, and possibly some others with girths greater than 200cm, are very likely to date from the first planting of the avenue in the 1870s/1880s. However, as the postcard shown in Figure 3.21 highlights, replanting was already taking place by the start of the twentieth century.

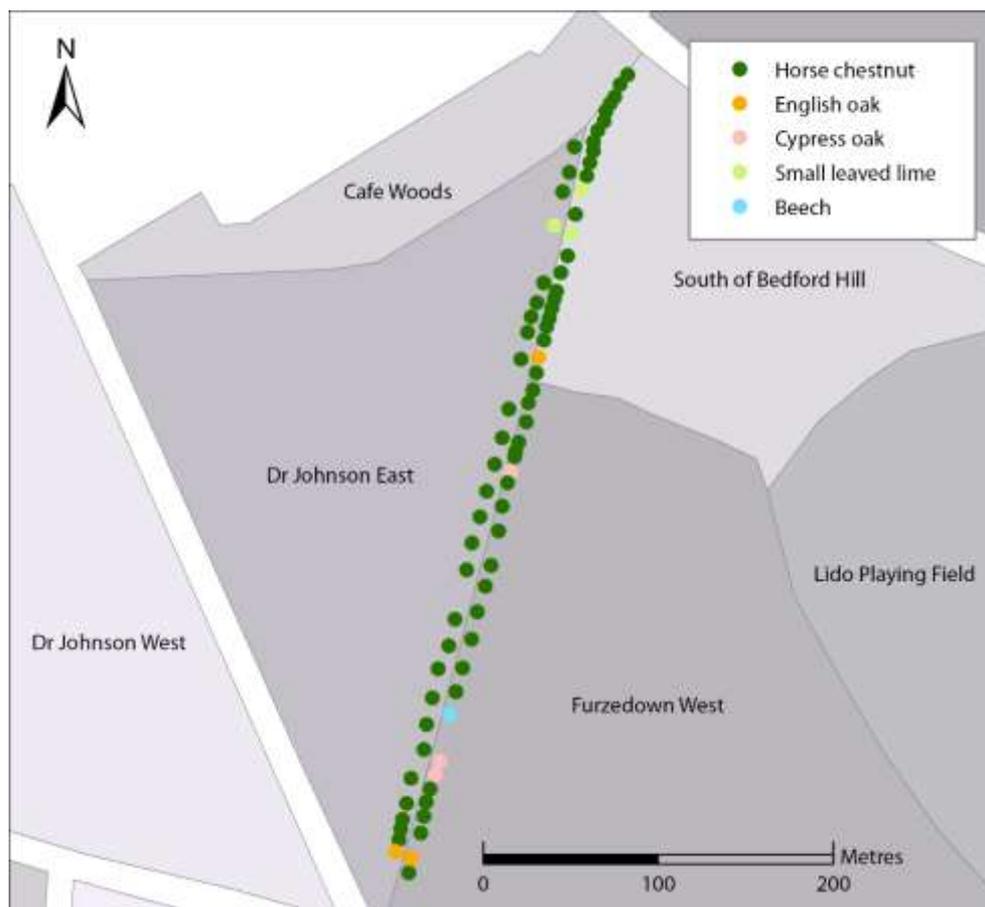
Figure 3.22 – Species composition of Chestnut Avenue.

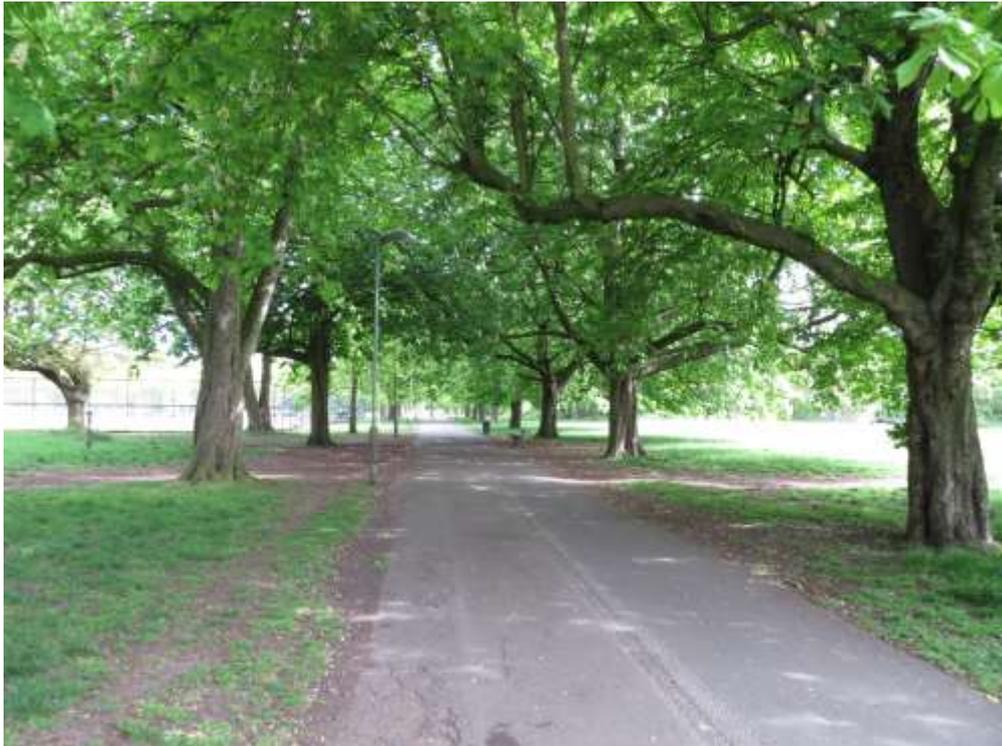
Figure 3.23 – Chestnut avenue, close to the tennis courts, looking north.

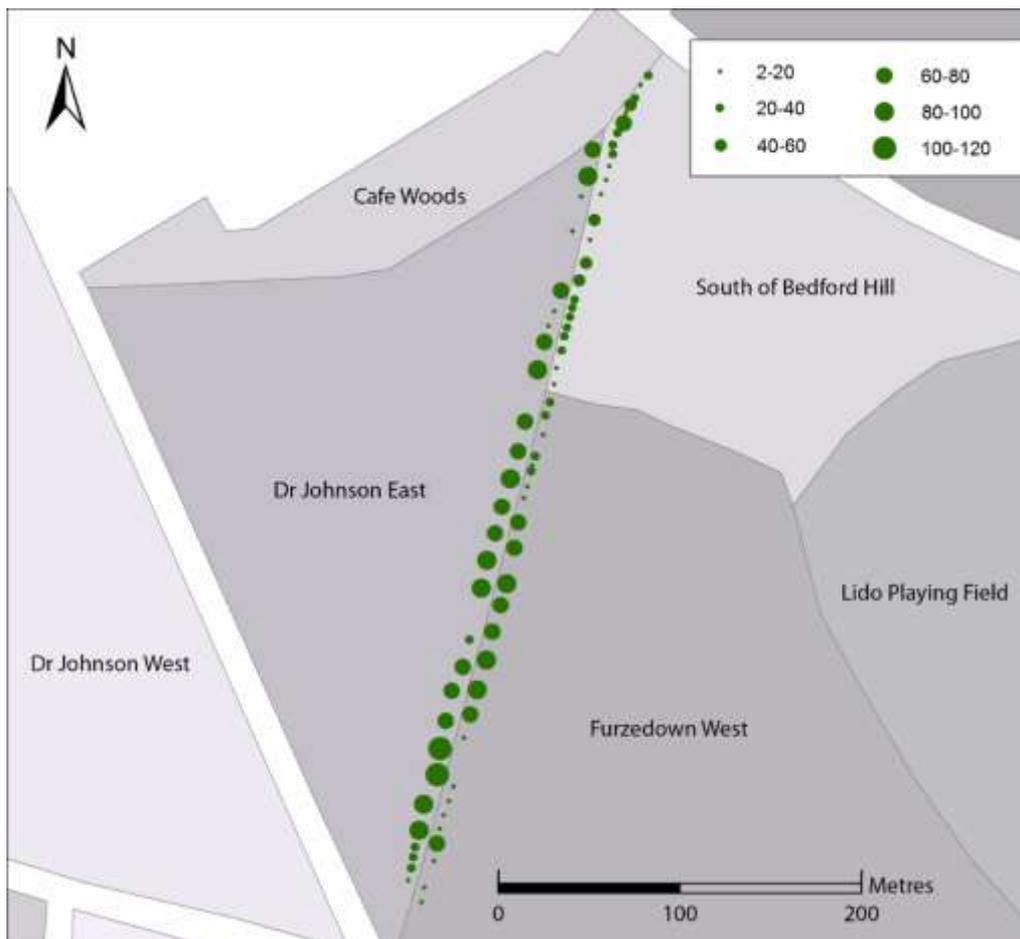
Figure 3.24 – Stem diameters of trees in Chestnut Avenue

3.8.3. Figure 3.24 illustrates the uneven character of the avenue, with numerous gaps and other sections dominated by recent planting. The majority of the mature specimens are found in the southern half of the avenue. Taking the avenue as a whole the average size of tree here is 43 cm in terms of stem diameter and 135cm for circumference.

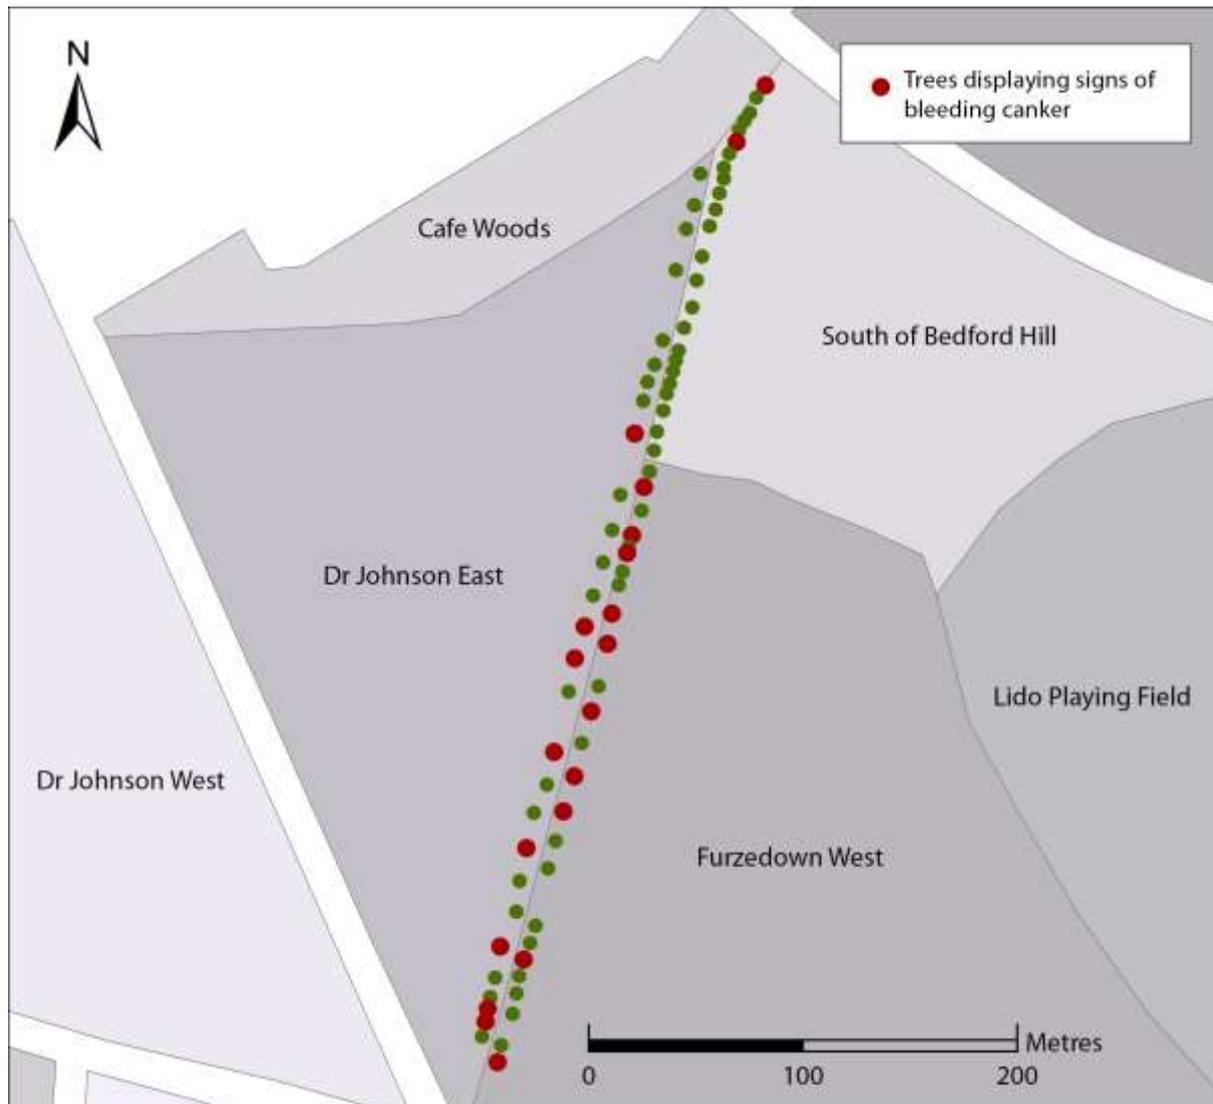
3.8.4. A tree condition survey carried out in March 2015 classed 30 of the trees as being in 'Good' condition and 43 as 'Fair'. Two trees were dead and two were recorded as 'Poor'. A total of 20 horse chestnuts of varying sizes and ages were identified as showing signs of bleeding canker disease (Treework Environmental Practice 2015).

Figure 3.25 – Trees displaying signs of bleeding canker in Chestnut Avenue.

Issues	Suggested Actions
<p>Health and viability of horse chestnut.</p> <p>Older specimens showing structural weakness and decay</p> <p>Reduced aesthetic appeal of leaves affected by fungus and leaf mining moths.</p>	<p>Given its current condition and the likelihood of further problems in future serious consideration should be given to replanting of the avenue with another species.</p> <p>Careful thought needs to be given to the question of what to replant with. Planting with sweet chestnut would provide some degree of continuity, and it has a long history of use as an avenue tree.</p> <p>Small-leaved lime might also be considered as an alternative.</p>
<p>Historical context</p>	<p>The history of this avenue is better understood than the others given its more recent origins, but further research could be conducted into exactly when and why it was planted and how it developed.</p> <p>The existing avenue should be recorded and documented before any significant work takes place. A list of trees currently in the Avenue has been recorded as part of the Tree Condition Survey. This could be supplemented with a photographic survey recording views of the Avenue at different points. These should include images taken from within the Avenue, and from surrounding areas looking towards the Avenue.</p>

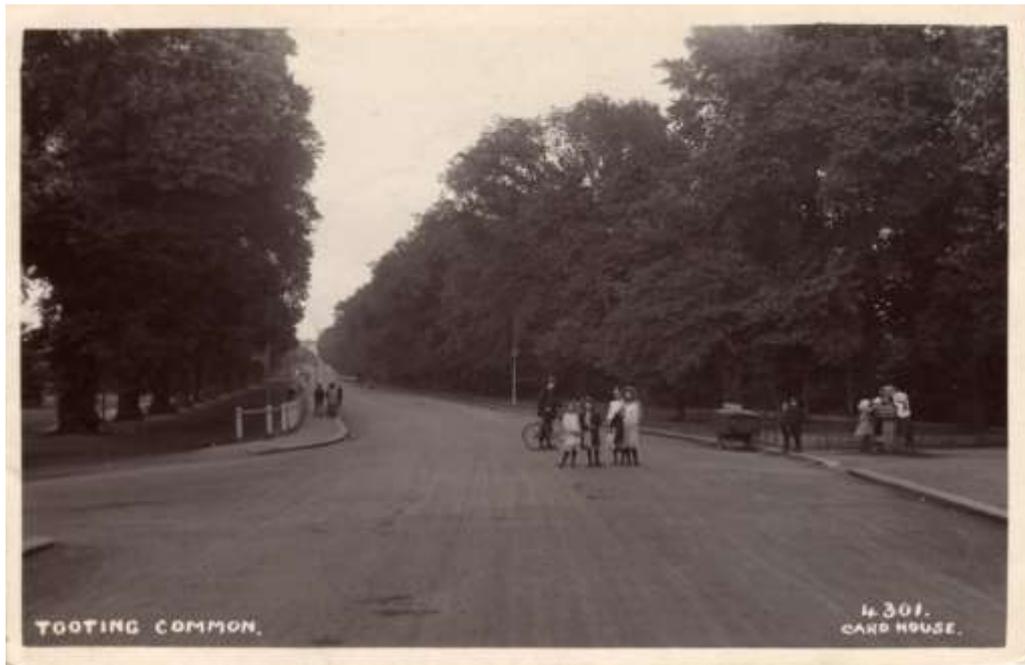
Figure 3.26 – Tooting Bec Road in 1911 (Patrick Loobey Collection).

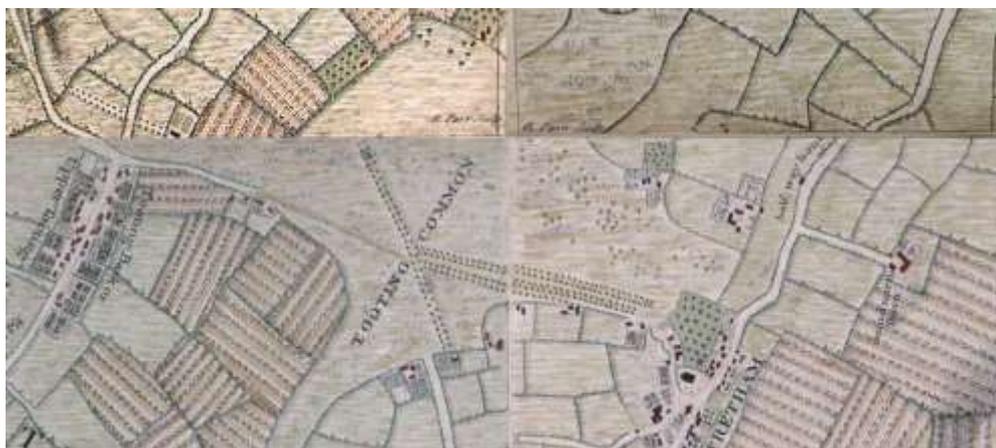
Figure 3.27 – Rocque's 1746 map of London, showing a double avenue running along the line of the Tooting Bec Road.
