Tooting Common

Heritage Tree Survey

The Landscape Group, University of East Anglia

May 2015

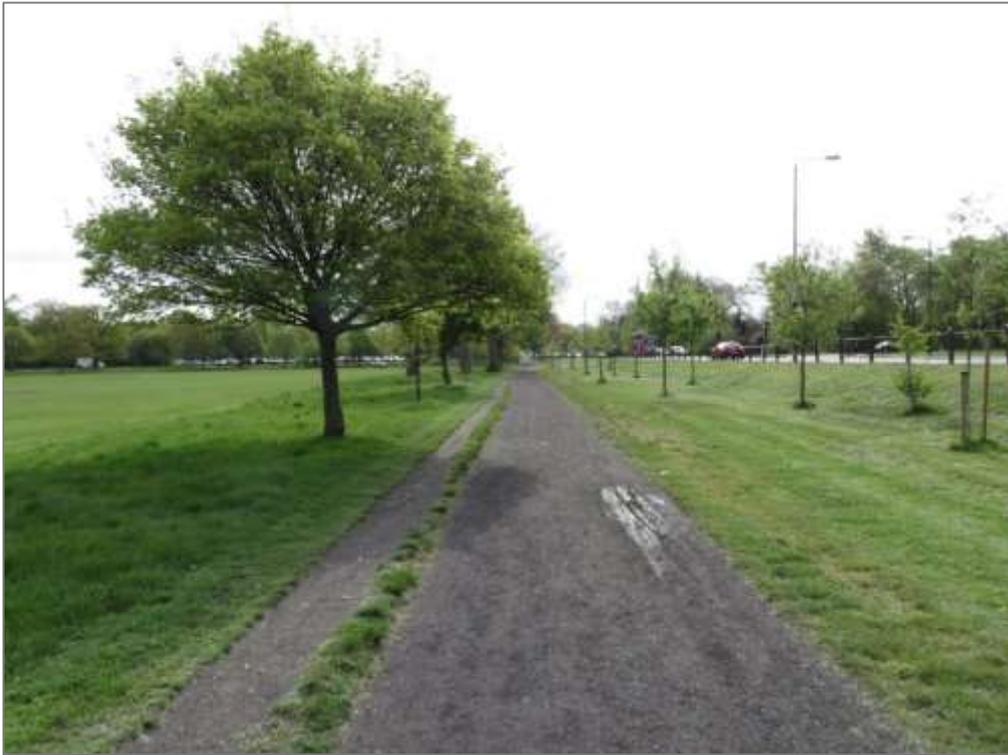
Figure 3.29 – Recently planted trees at the western end of Tooting Bec Road. Tooting Graveney Common, looking east.

- 3.9.6. The trees which mark the approximate line of the former avenue today are very varied in species, age and size, although the majority represent recently established or planted trees little more than a few decades (and in some cases a few years) old. The best represented species include hornbeam (*Carpinus betulus*), small-leaved lime, Norway maple (*Acer platanoides*), horse chestnut, Turkey oak and sycamore (*Acer pseudoplatanus*).

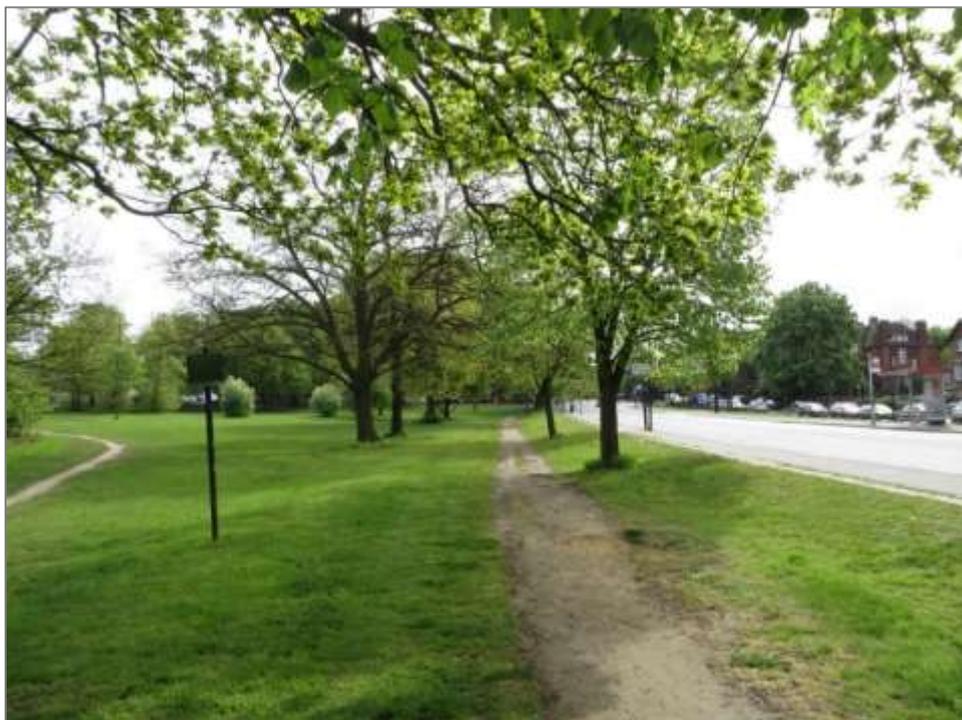
Figure 3.30 – The line of the former avenue on the north side of Tooting Bec Road picked out by a sparse collection of more recently planted trees. Looking east towards the junction with Garrad's Road.

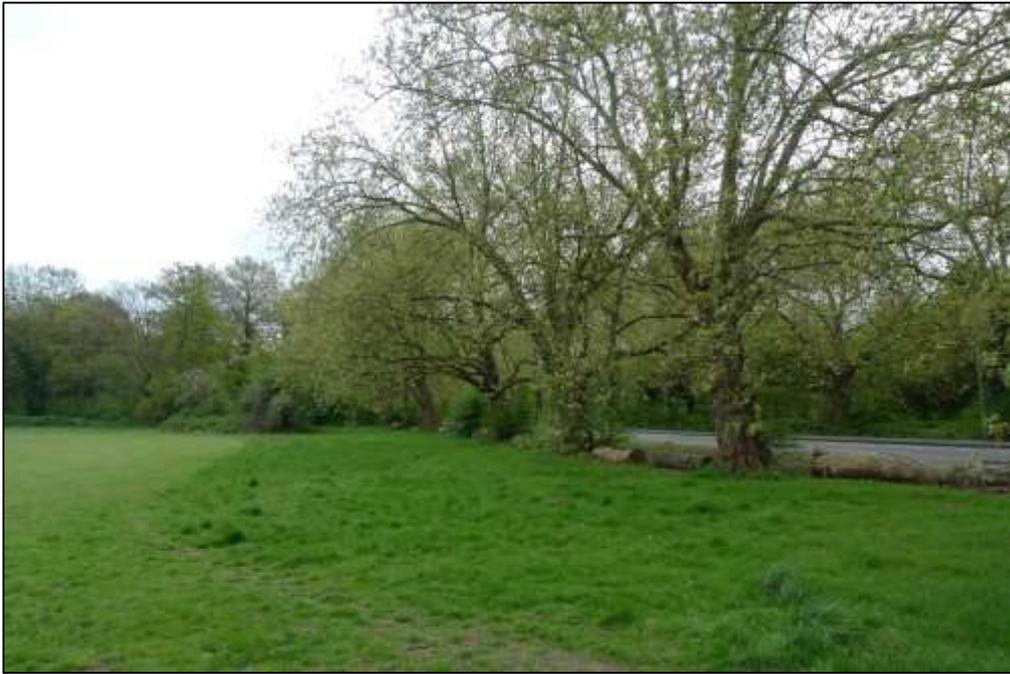
Figure 3.32 – London planes at the north western end of Bedford Hill.

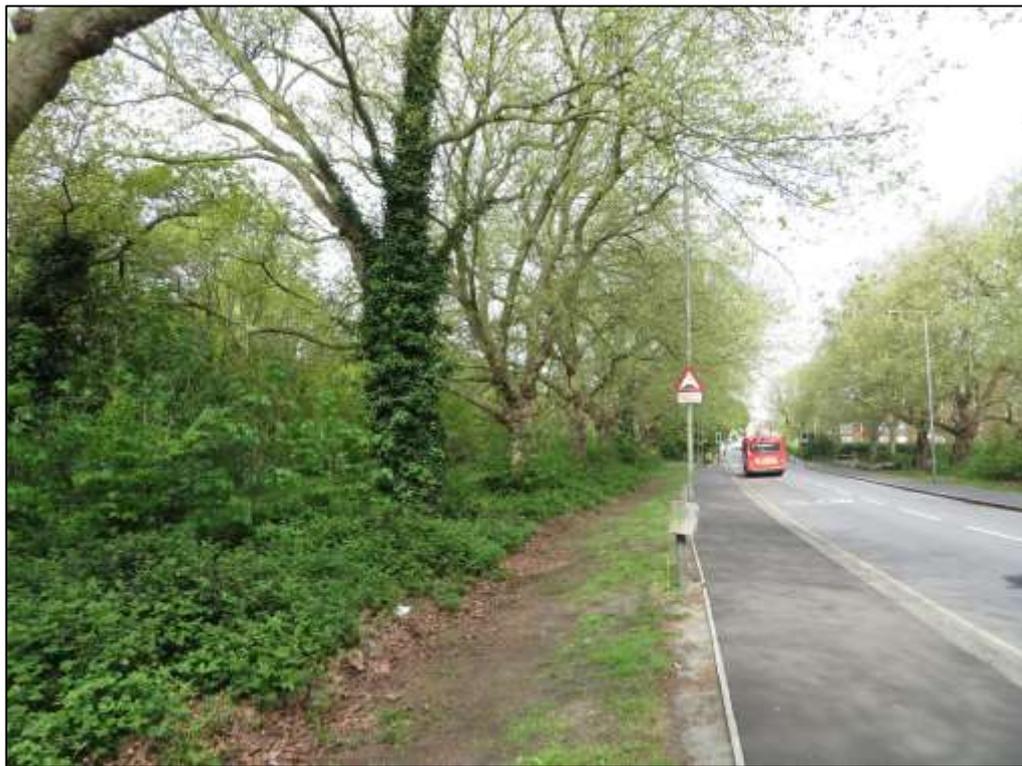
Figure 3.33 – Bedford Hill, looking towards the western edge of Tooting Common and showing the rows of plane trees on either side of the road.

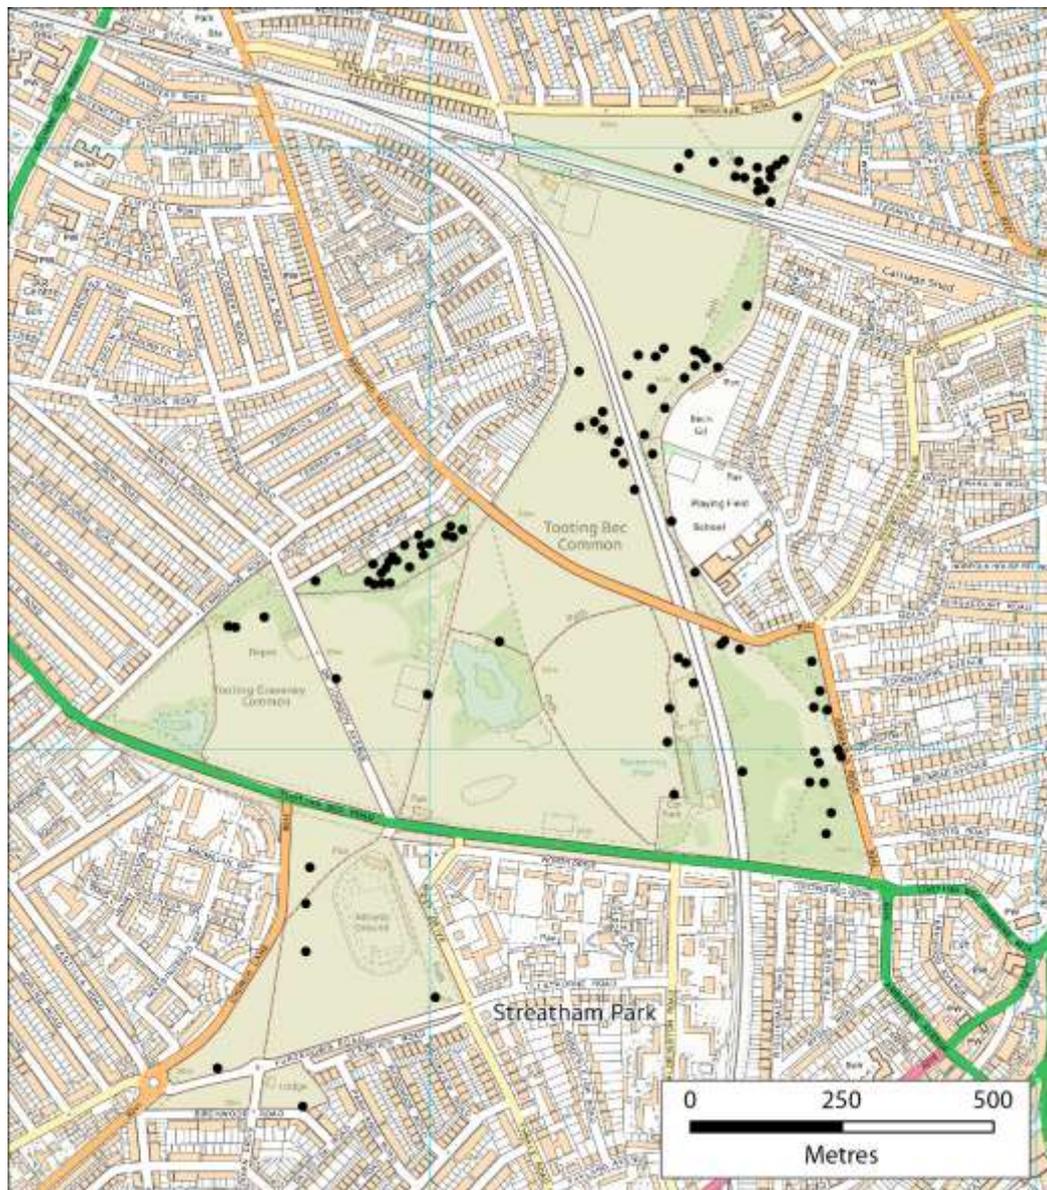
4.3.2. Figure 4.1 shows the distribution of veteran trees across Tooting Common and highlights the fact that they tend to be found in one of four clusters, discussed in more detail below:

Figure 4.1 – The distribution of veteran trees on Tooting Common (Contains Ordnance Survey data © Crown copyright and database right 2015).

Recommendations for management of veteran trees from 2015 Tree Condition Survey (Treework Environmental Practice 2015)	
Issue	Action
Crowding of veteran trees	Phased halo thinning around affected trees
Soil compaction and waterlogging	Soil amelioration and exclusion around vulnerable trees
Risks posed by tree health and condition	Set up inspection programme (involving volunteers) to inspect trees every two years.

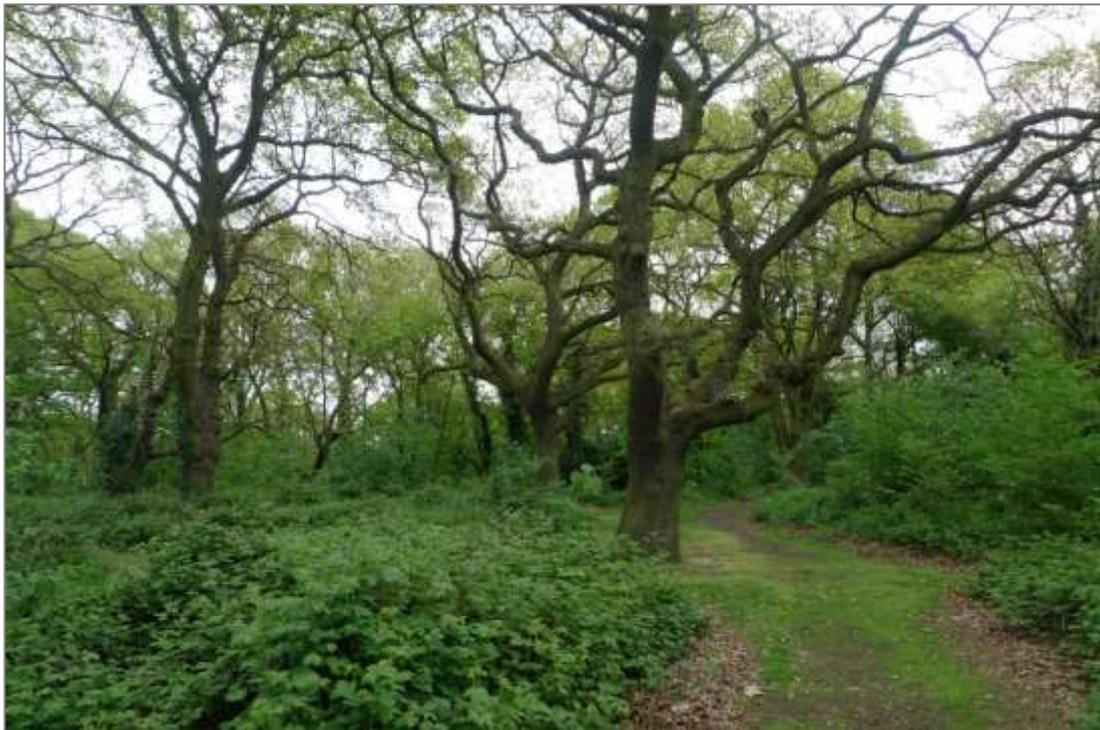
Figure 4.2 – Veteran oaks surrounded by younger trees which represent the regeneration of woodland in the twentieth century.

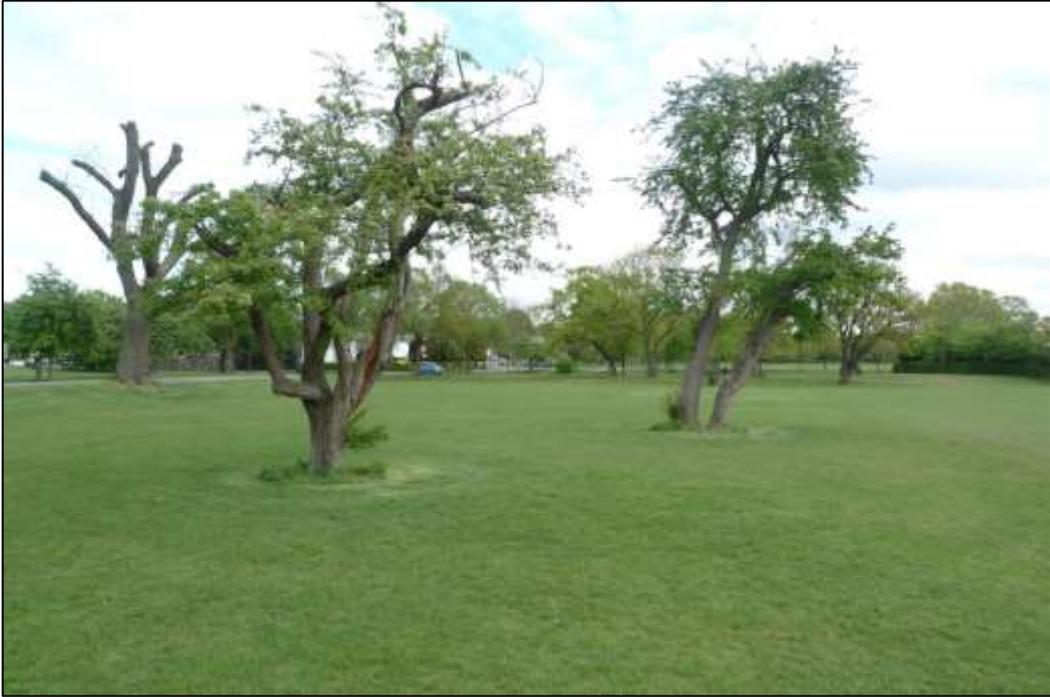
Figure 4.6 – Veteran hawthorns near Dr Johnson Avenue. Even very old thorns have relatively modest girths compared to other species of similar age.

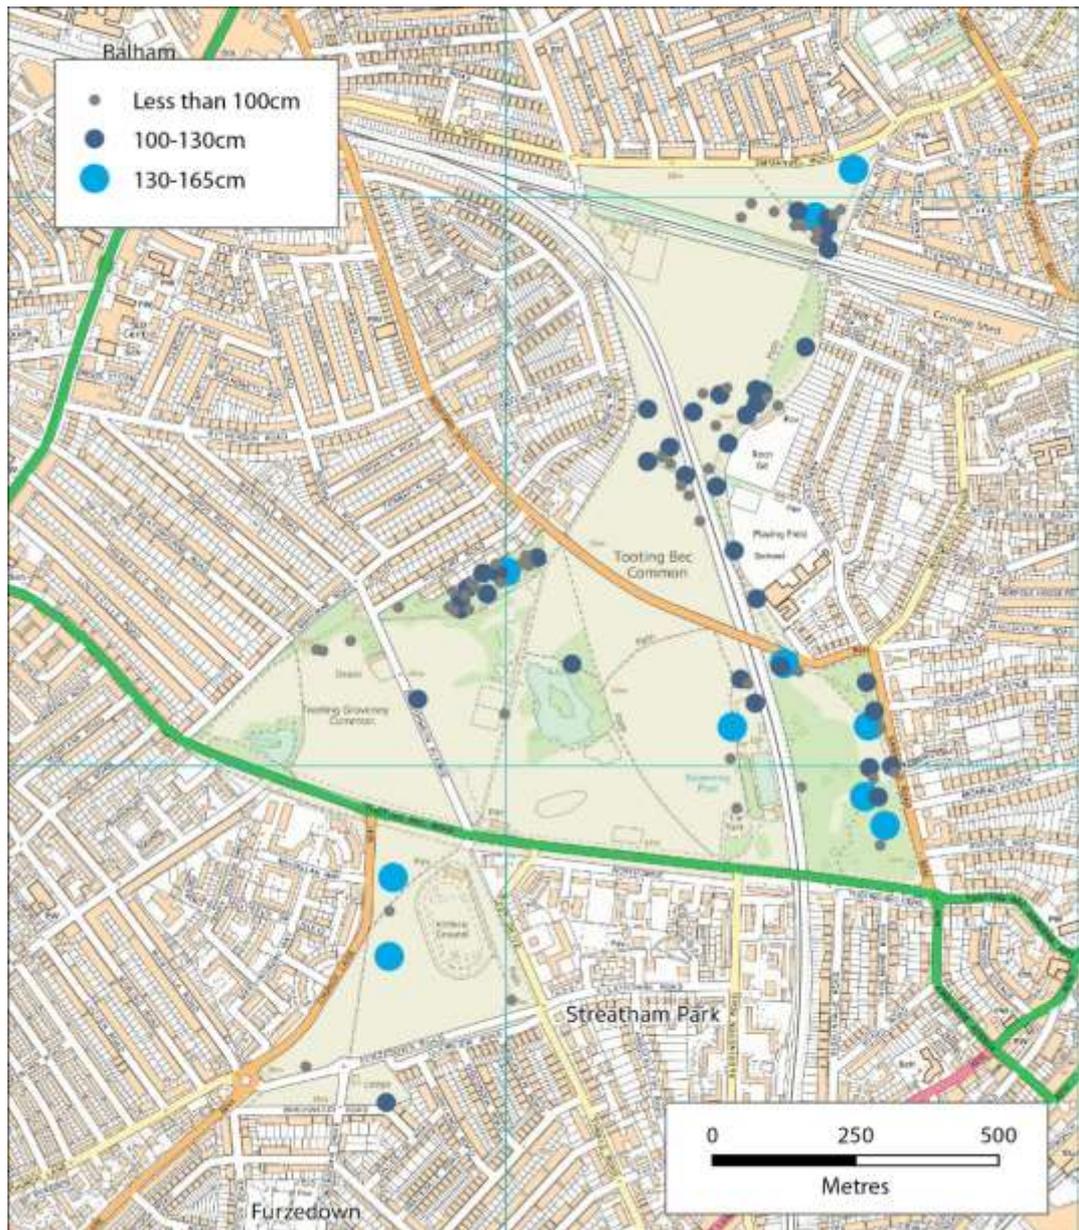
4.3.10. The 97 veterans display a range of sizes, relating partly to species. The veteran oaks have an average stem diameter of 104cm compared to 68cm for the veteran hornbeams and 39cm for the veteran hawthorns. Of the ten largest trees, measured by stem diameter, 8 are English oaks, 1 is a red oak and 1 a black poplar. These trees all have circumferences in excess of 4 metres and most are found in the south-eastern corner of the Common.

Figure 4.7 – Veteran trees by stem diameter size. The largest ten veterans all have stem diameters of 130cm or more (Contains Ordnance Survey data © Crown copyright and database right 2015).

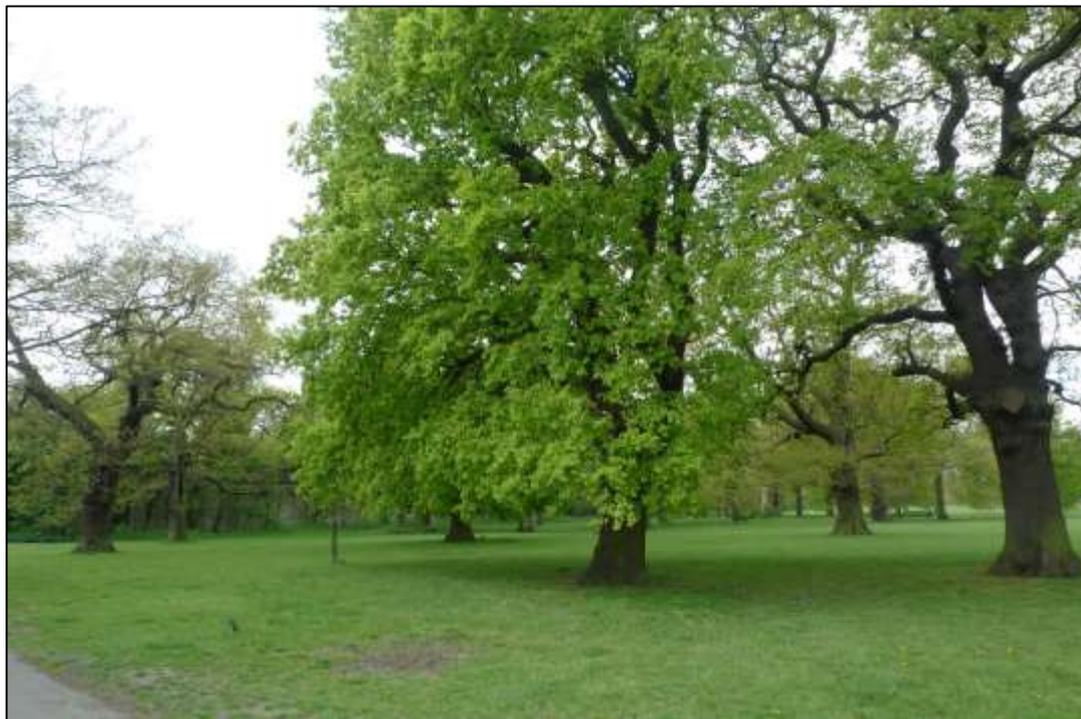
Figure 4.9 – Veteran oaks near Emmanuel Road, including some examples which appear to have been managed as pollards.

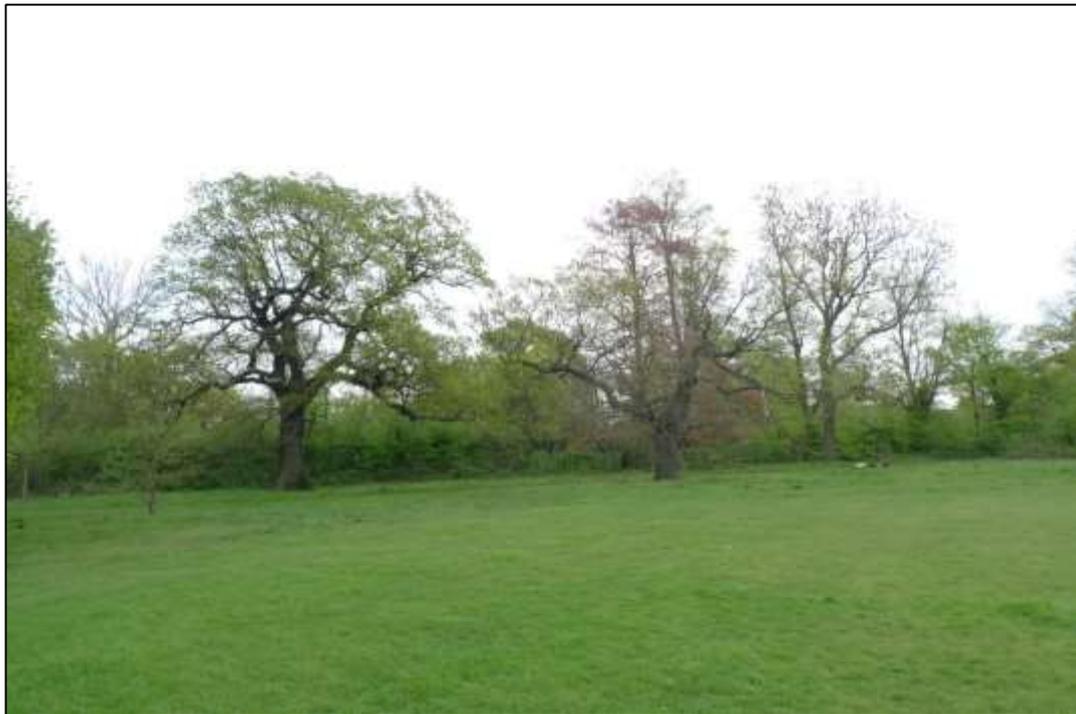
Figure 4.10 – Veteran oaks north of Bedford Hill, close to the railway line.

4.4.4. The relationship between these trees and the railway supports Sexby's claim that the building of the railways had caused a great loss of trees across the Common (Sexby 1905, 221). As with the trees near Emmanuel Road, some of the oaks here appear to have been managed as pollards. The size of the surviving veterans (typical girths of between 3 and 4 metres) suggests that most date to the eighteenth or nineteenth century.

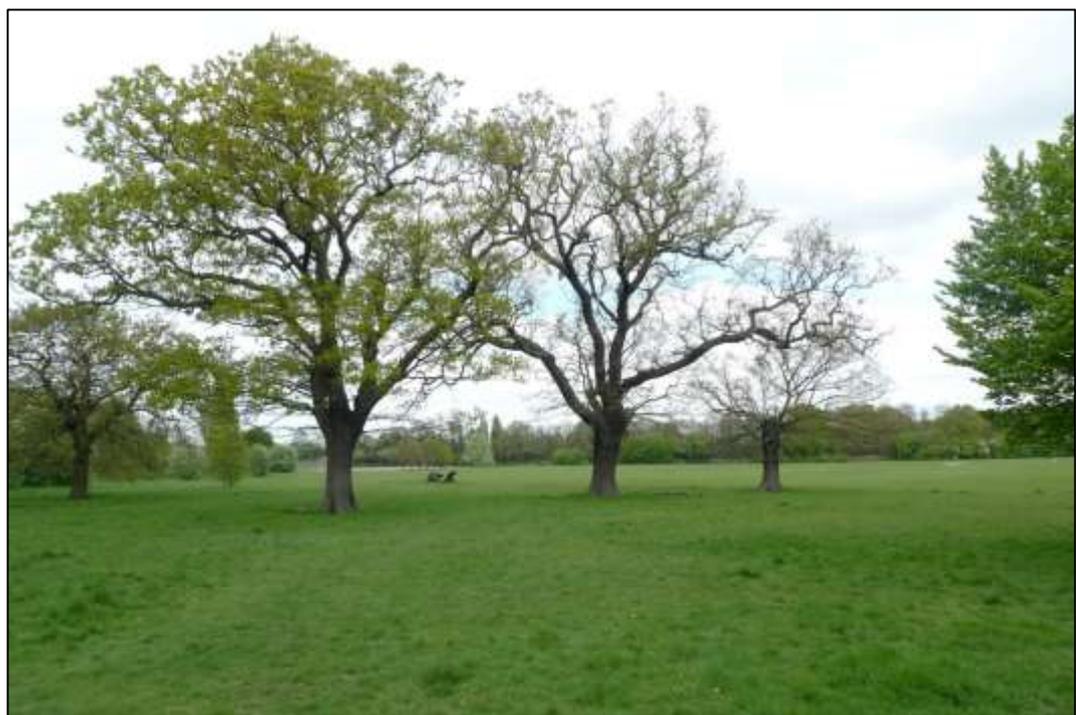
Figure 4.11 – Veteran oaks in the south of ‘The Triangle’, between the two railway lines. The pattern of branches suggests the trees may have been pollarded at some point.

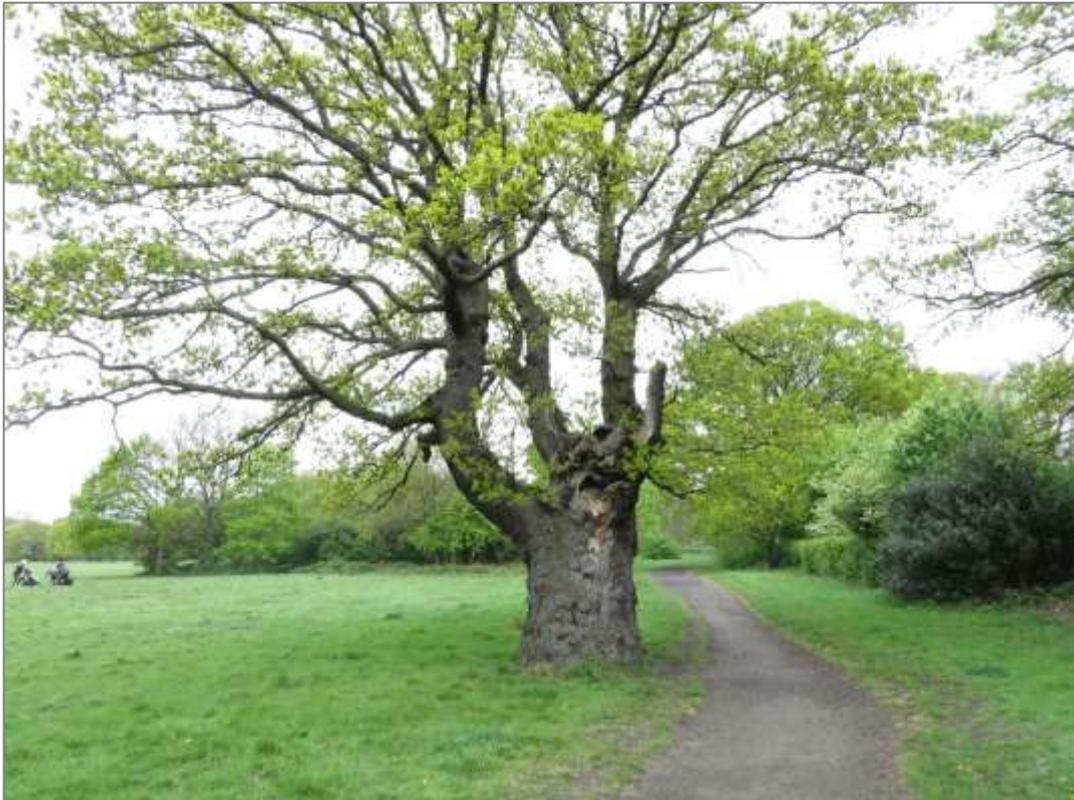
- 4.4.6. One excellent example of an English oak pollard which is clearly a survivor from the earlier Common landscape can be found close to the path that runs to the west of the Lido. This has a much more gnarled appearance than many of the other veteran oaks, although a girth of about 3.5 metres suggests that it may date to no earlier than the eighteenth century. Pollards of the same age can, however, display a wide variation in size so it is difficult to offer a precise date (Barnes and Williamson 2011, 40-43). This example is clearly rather older than some of the other pollards found nearby (Figure 4.15), although these smaller pollards are interesting in suggesting that pollarding may have continued until quite a late date in the history of the Common.

Figure 4.13 – A gnarled oak pollard on the path next to the Lido, likely to be one of the oldest surviving trees on the Common.

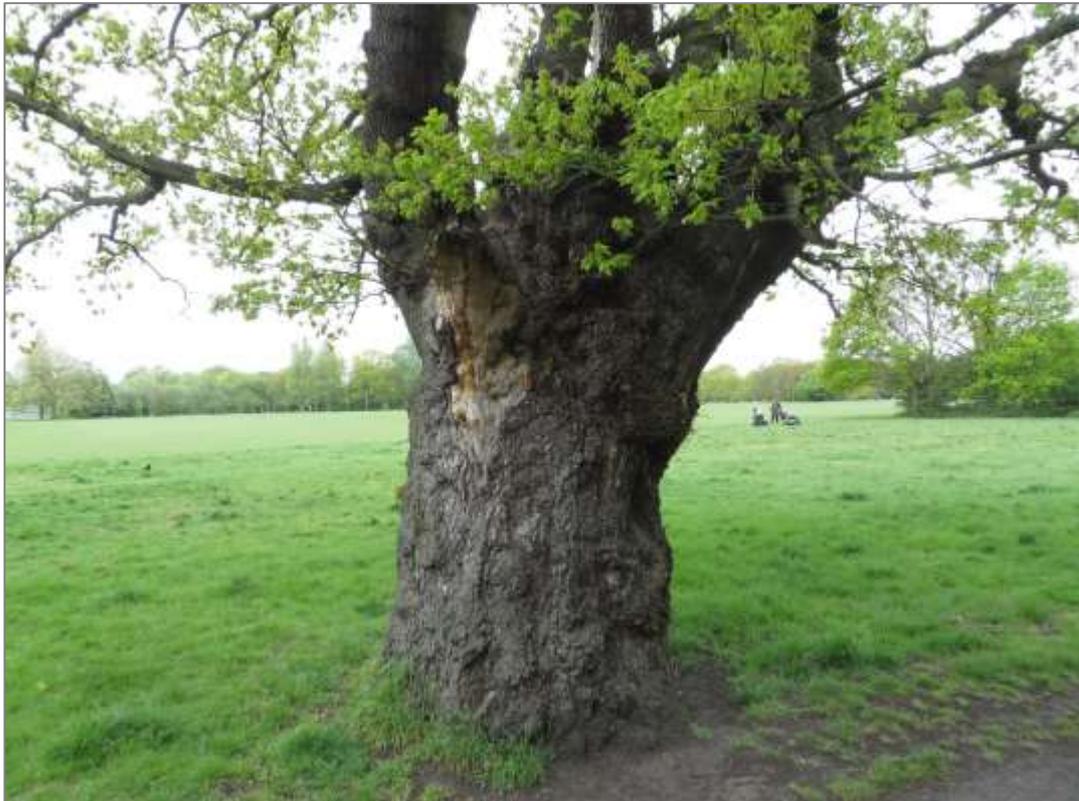
Figure 4.14 – A closer view of the same oak pollard.

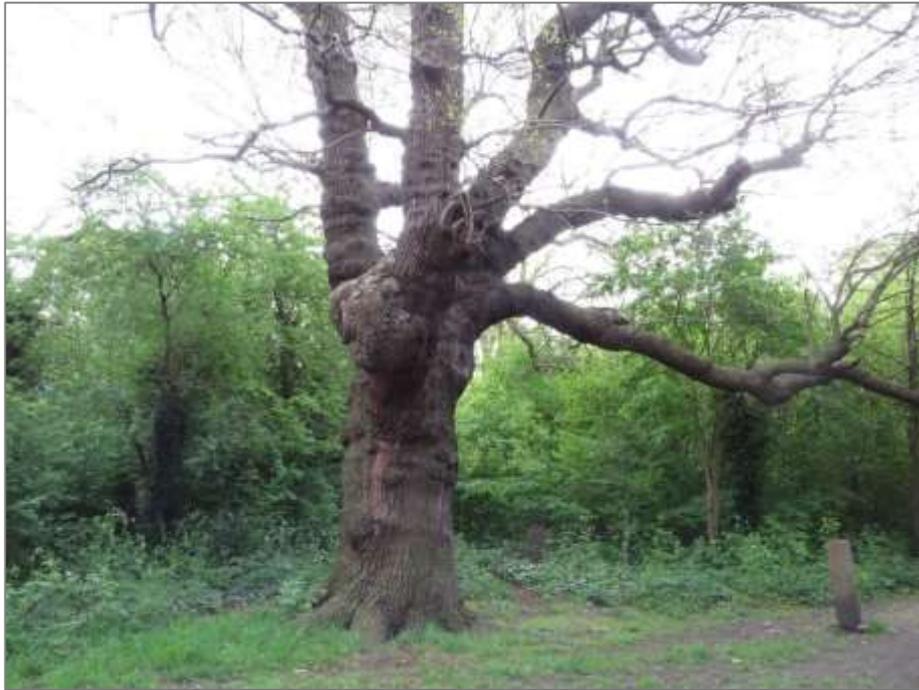
Figure 4.15 – Veteran oak pollard in Streatham Woods.

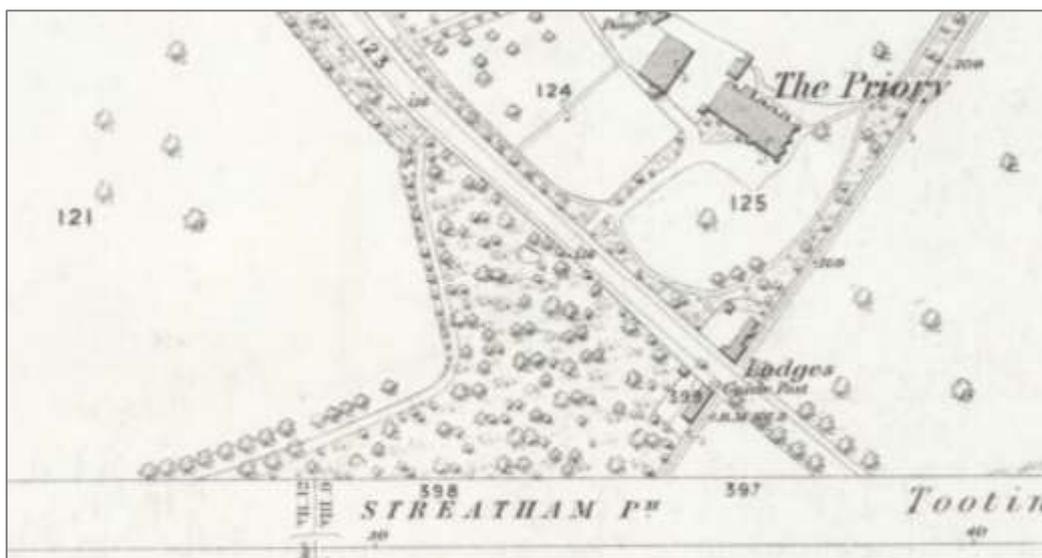
Figure 4.16 – The eastern end of Café Woods, shown as a much larger area of woodland on the edge of the grounds of Bedford Hill House. OS 25 inch to 1 mile map, 1875.

A cluster of 20 veteran oaks was recorded on the edge of the Common near Hillbury Road. These are all broadly similar in size and appearance, with girths of between 2.5 and 3.5 metres. The 1895-6 Ordnance Survey 25 inch to 1 mile map suggests that the concentration of trees here was even greater in the late nineteenth century. The trees are not shown on Stanford's 1862 map, but they do appear on the first edition 25 inch map of 1875. This shows a dense group of trees, forming the boundary between the grounds of Bedford Hill House and Tooting Bec Common.

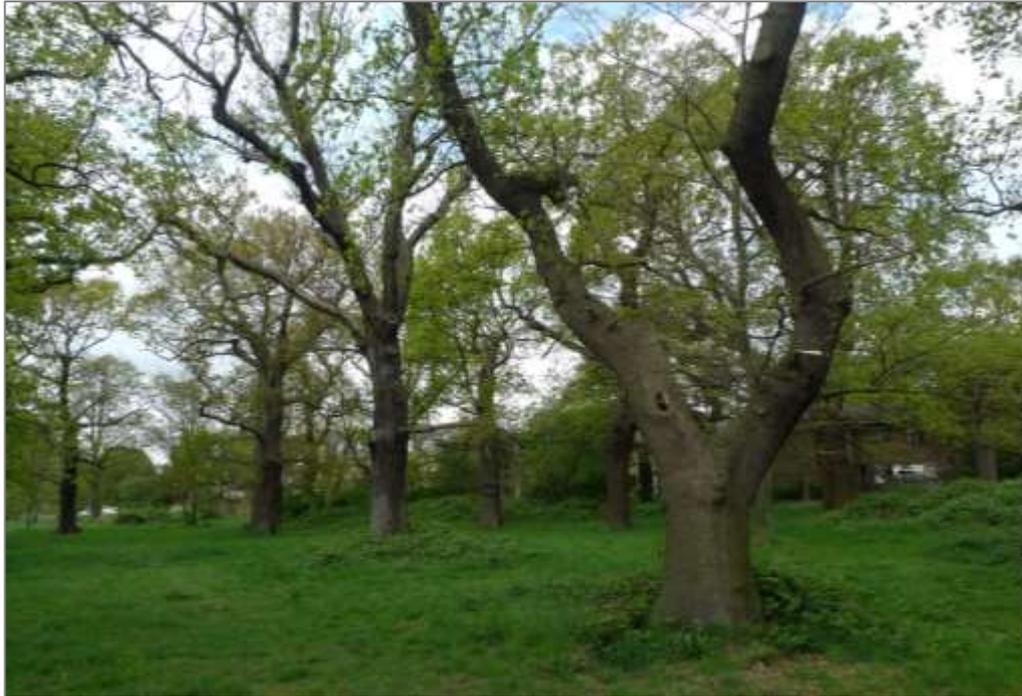
Figure 4.17 – Veteran oaks in Café Woods.
